AGENDA
WORK SESSION OF THE VENETA CITY COUNCIL
MONDAY, FEBRUARY 9, 2015 – 6:00 P.M.
Veneta Administrative Center, 88184 8th Street, Veneta, Oregon

Title/Topic: Pavement Condition Survey and Evaluation Report

EXECUTIVE SUMMARY

Pavement Management Study

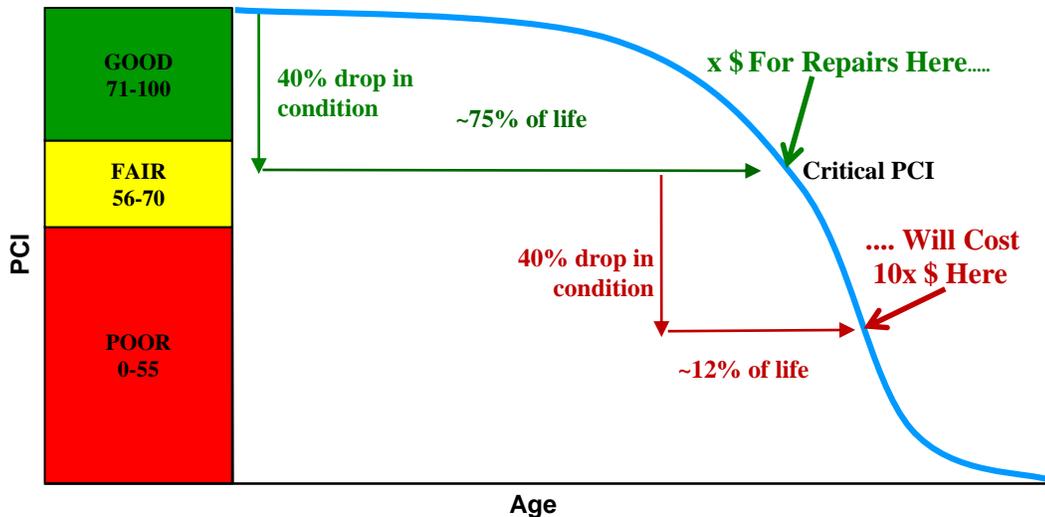
Figure 2 – Typical Pavement Deterioration Curve

Depending on design life and preventive maintenance, the typical pavement condition trend is for a slight deterioration right after construction and then the deterioration levels off. The leveling off period is where the deterioration condition slows relative to time. The period of slower deterioration is when the majority of the desired condition, use, and life of the pavement occurs. At the end of the “leveling off” period, there is a transition point referred to as the critical PCI. After the critical PCI is reached, the pavement condition typically deteriorates more quickly into a poor condition state. An example of typical pavement deterioration is presented in Figure 2.

Ideally, if preventive maintenance is performed before the critical PCI is reached, the life and use of the pavement can be extended in the leveling off period. Also, any major restoration work, such as overlay, that is done before a pavement deteriorates below the critical PCI usually costs substantially less than would be required if the rehabilitation work is delayed, due to the better condition of the pavement.

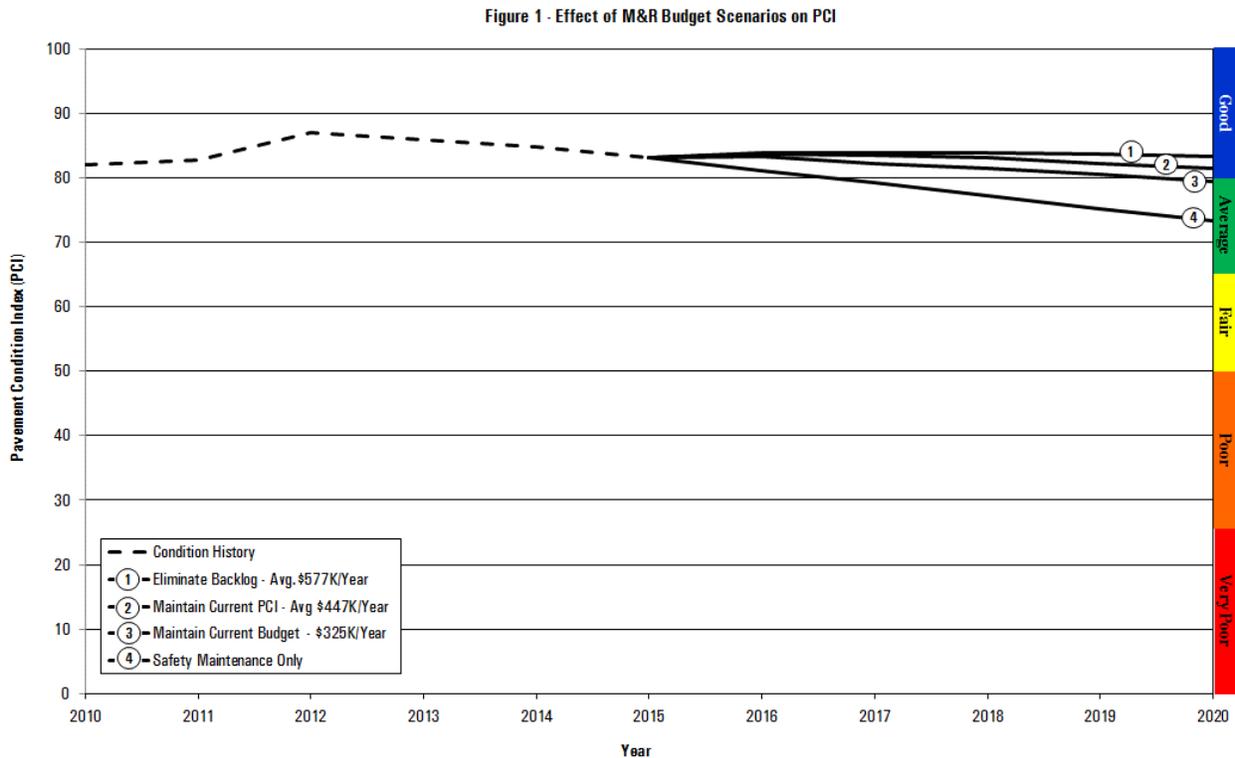
Figure 3 – Effects of Various Budget Scenarios on PCI

Figure 3 shows the effect of the four budget scenarios on the resulting condition of the Veneta street system.

PSI analyzed four different budget scenarios based on either a specific budget requirement or a pavement condition constraint. Based on our analysis, we offer the following conclusions:

Scenario 1. An annual expenditure of \$577K from 2015-2020 would eliminate the M&R backlog for the entire street system. The resulting funding needs from 2021-2025 would decrease to \$193K annually.

Scenario 2. In order to stabilize the condition of the street system at the current PCI of 83, an annual budget of \$447K is required during the period of 2015-2020. At this level of investment, the unfunded M&R shrinks from \$2.70M to \$458K by year 2020.

Scenario 3. At the current funding level of \$325,000 annually, the unfunded M&R will reduce to \$1.42M by the year 2020.

Scenario 4. If only safety maintenance such as pothole filling is performed until 2020, the unfunded M&R will grow from \$2.70M to \$3.12M and the average PCI will drop from 83 to 73.

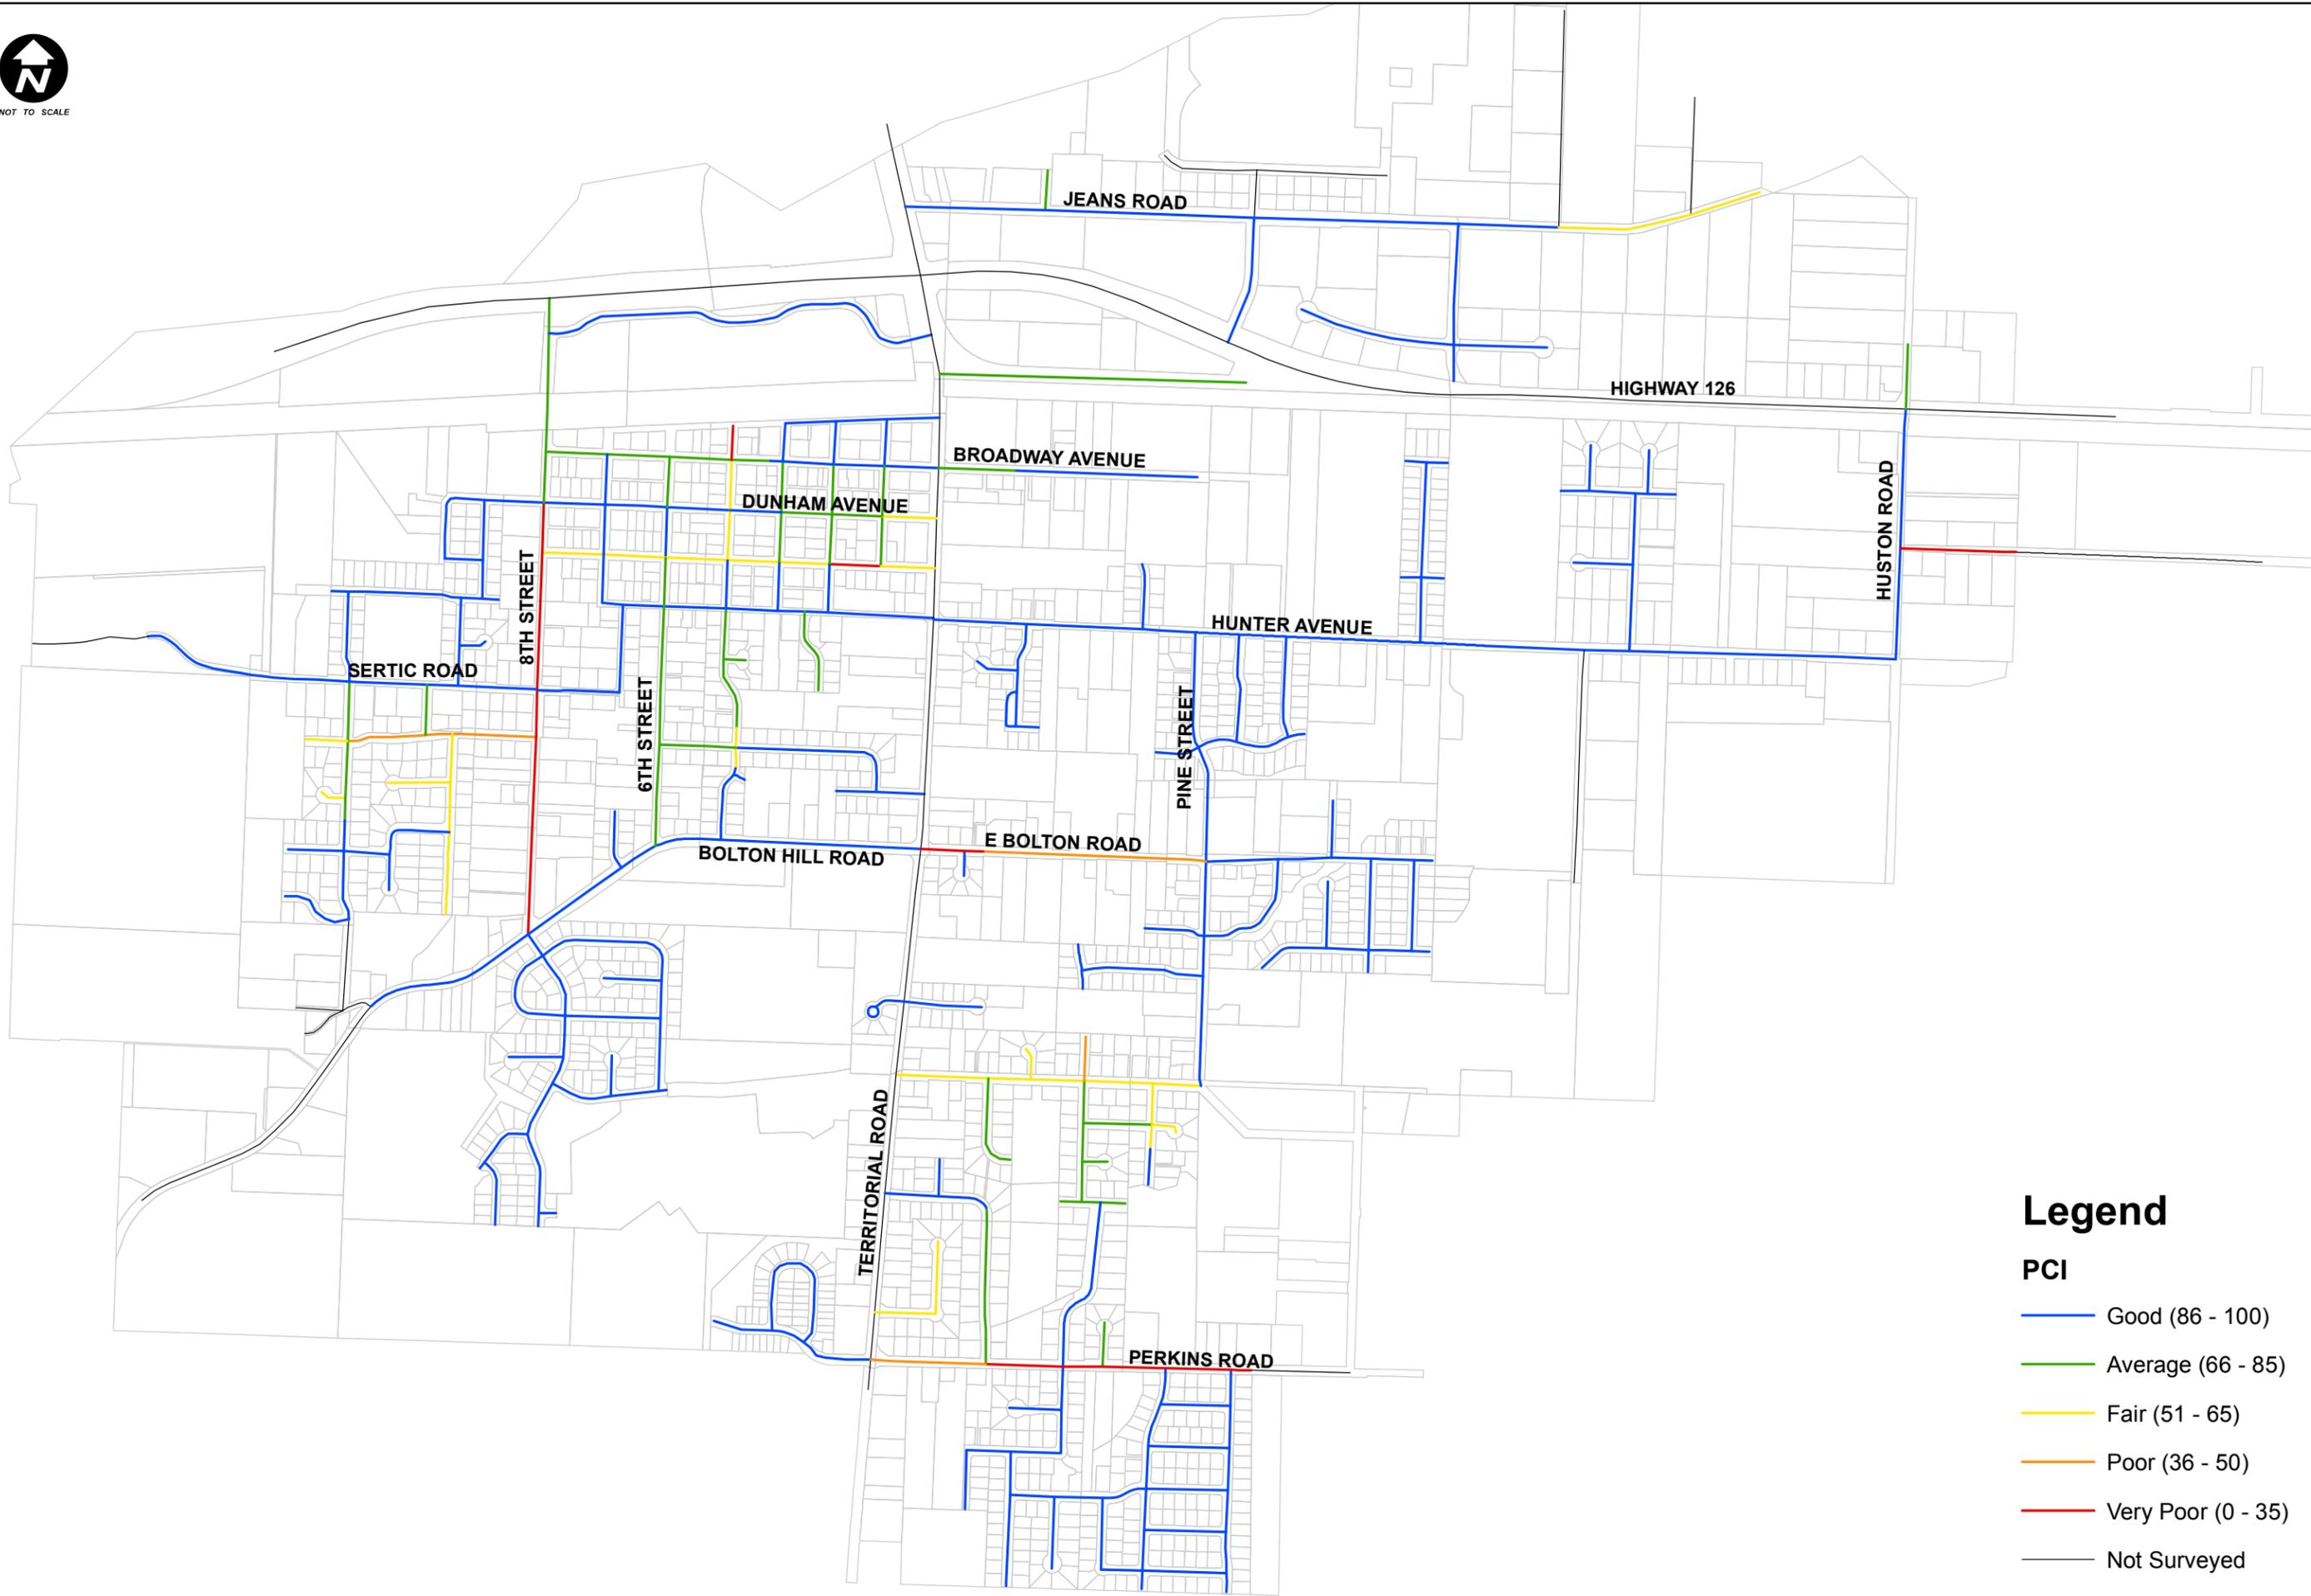
The overall area weighted average condition of the Veneta street system is rated as 83 or “Good”. The PCI scale used was Good, Average, Fair, Poor, and Very Poor; where Good is from 100 to 81, Average is 80 to 66, Fair is 65 to 51, Poor is 50 to 36, and Very Poor is 35 to 0. The pavement condition distribution in Veneta is 73.5% Good, 11.6% Average, 8.6% Fair, 2.5% Poor, and 3.8% Very Poor. Figure 1 presents a map with the baseline street condition resulting from the 2014 PCI survey.

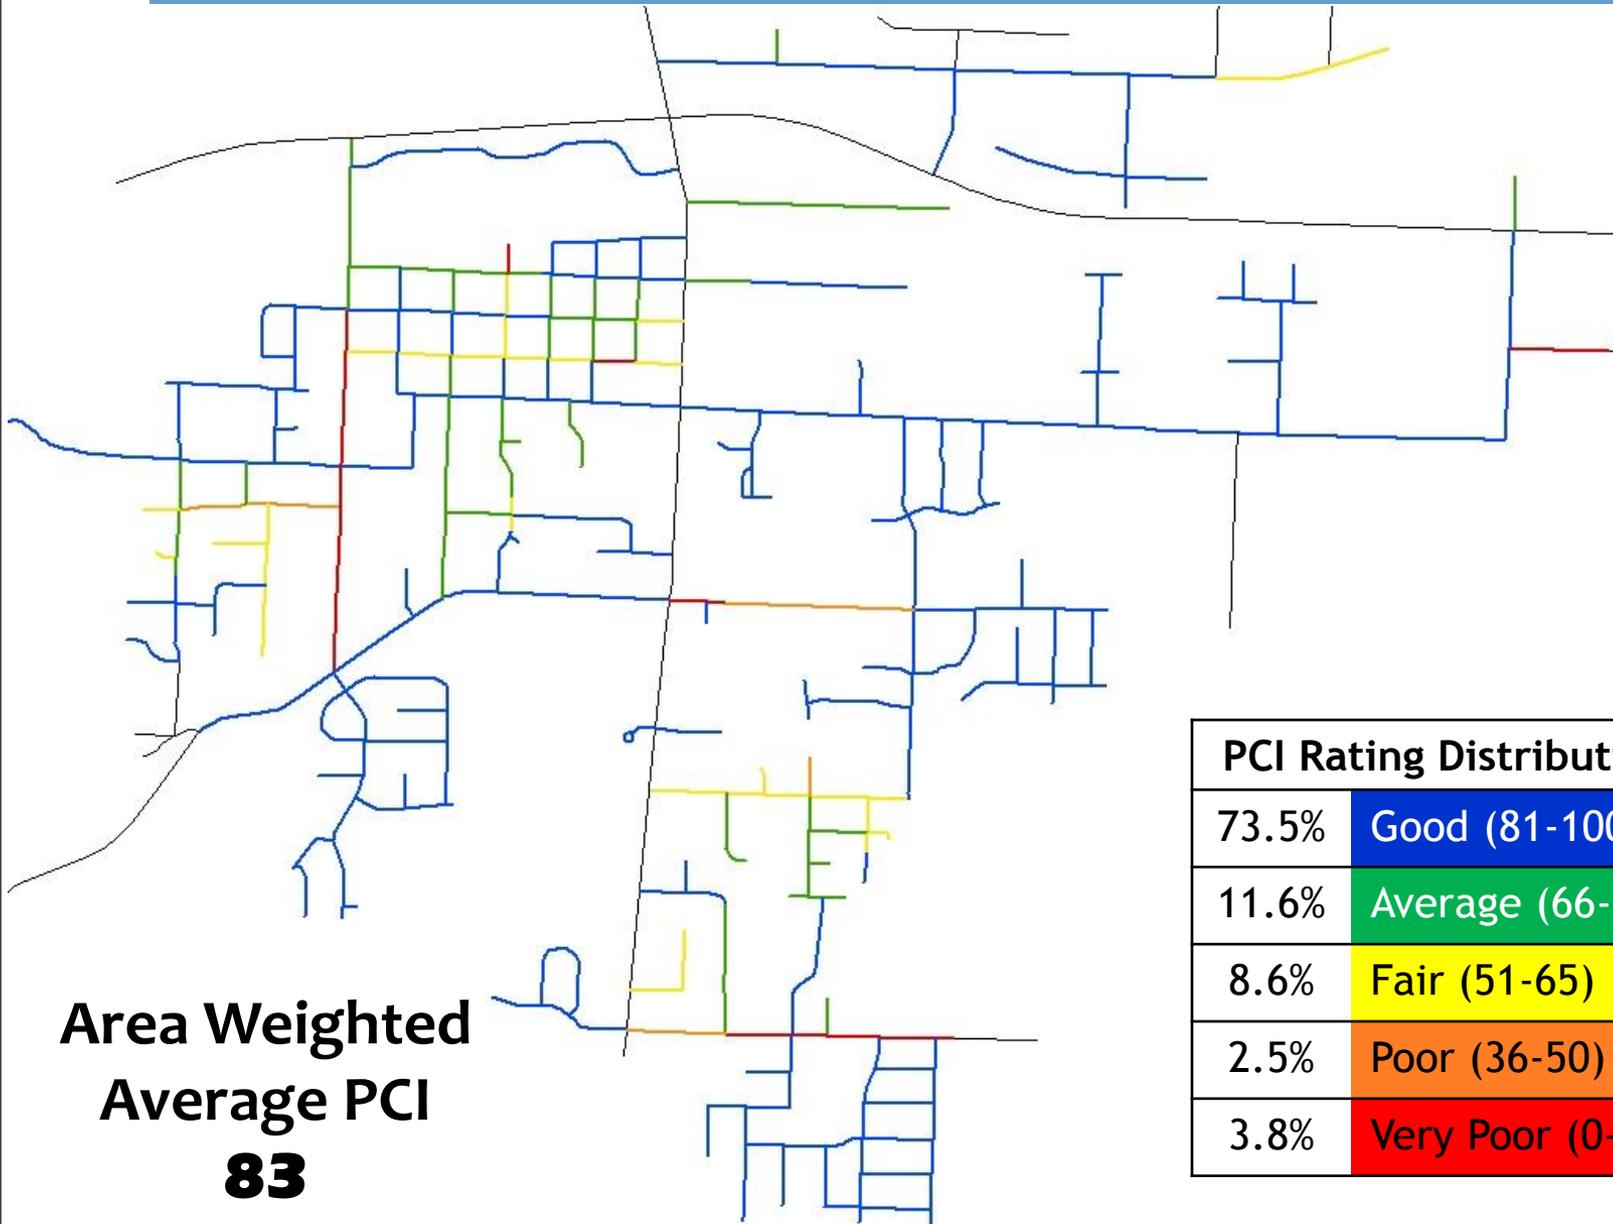
2014 PCI Survey Results

**Area Weighted
Average PCI
83**

PCI Rating Distribution	
73.5%	Good (81-100)
11.6%	Average (66-80)
8.6%	Fair (51-65)
2.5%	Poor (36-50)
3.8%	Very Poor (0-35)

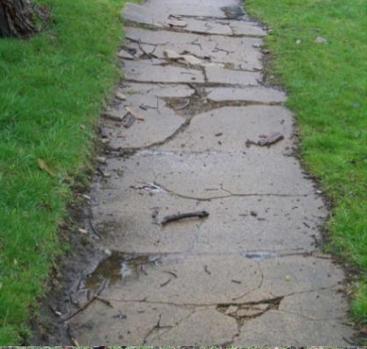
Sidewalk Survey

inventoried sidewalk
on

- ▶ Inventoried sidewalk width
- ▶ Determined sidewalk condition
- ❖ Developed Condition Rating Criteria

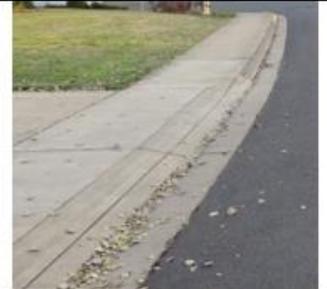
Excellent Condition

- Uniform & Flat Cross Slope
- No Slab Faulting
- No Cracks
- No Obstacles

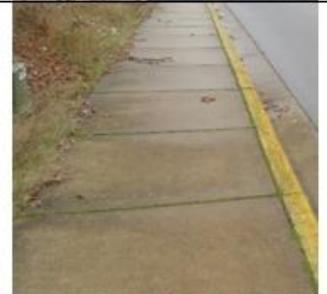
Good Condition

- Uniform & Flat Cross Slope
- No Slab Faulting
- Minimal Cracks < 1/4"
- No Obstacles

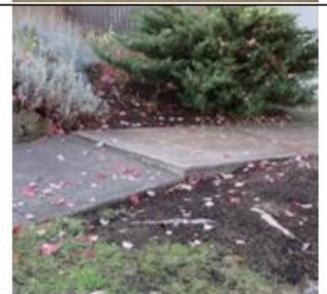
Fair Condition

- Slightly Non-Uniform Cross Slope
- Several Cracks > 1/4"
- Several Faulted Slabs or Obstacles

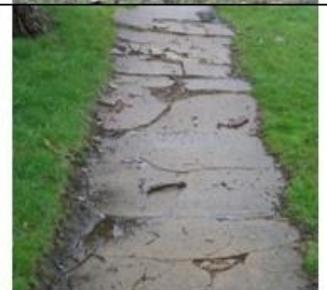
Poor Condition

- Non-Uniform Cross Slope
- Many Multi-Directional Cracks
- Missing Pieces of Concrete
- Significant Quantity of Faulted Slabs or Obstacles

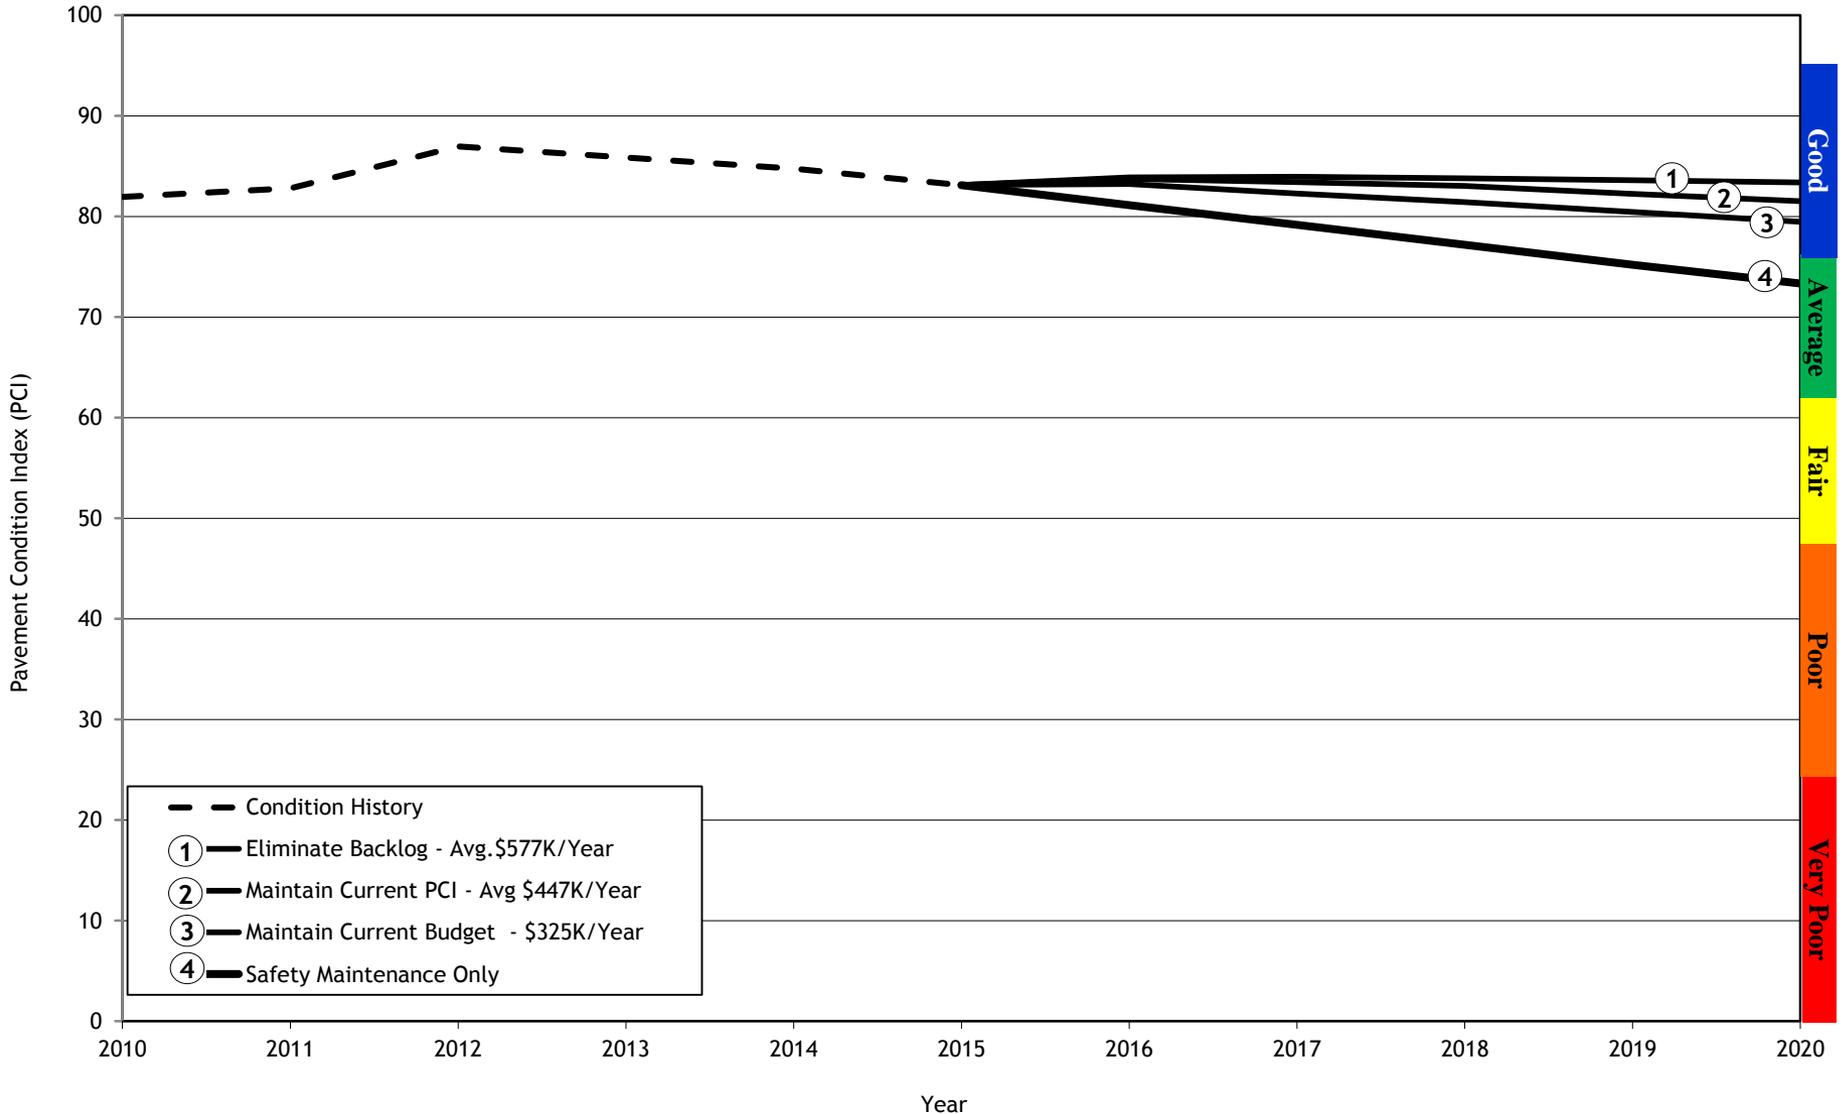
Effect of M&R Budget on PCI

1. Eliminate Backlog by 2020
 - \$577,000/year
2. Maintain Current PCI
 - \$447,000/year
3. Maintain Current Budget
 - \$325,000/year
4. Safety Maintenance Only
 - \$45,000/year

- Increase yearly budget from \$325K to \$447K until 2023 the City will eliminate it's unfunded M&R

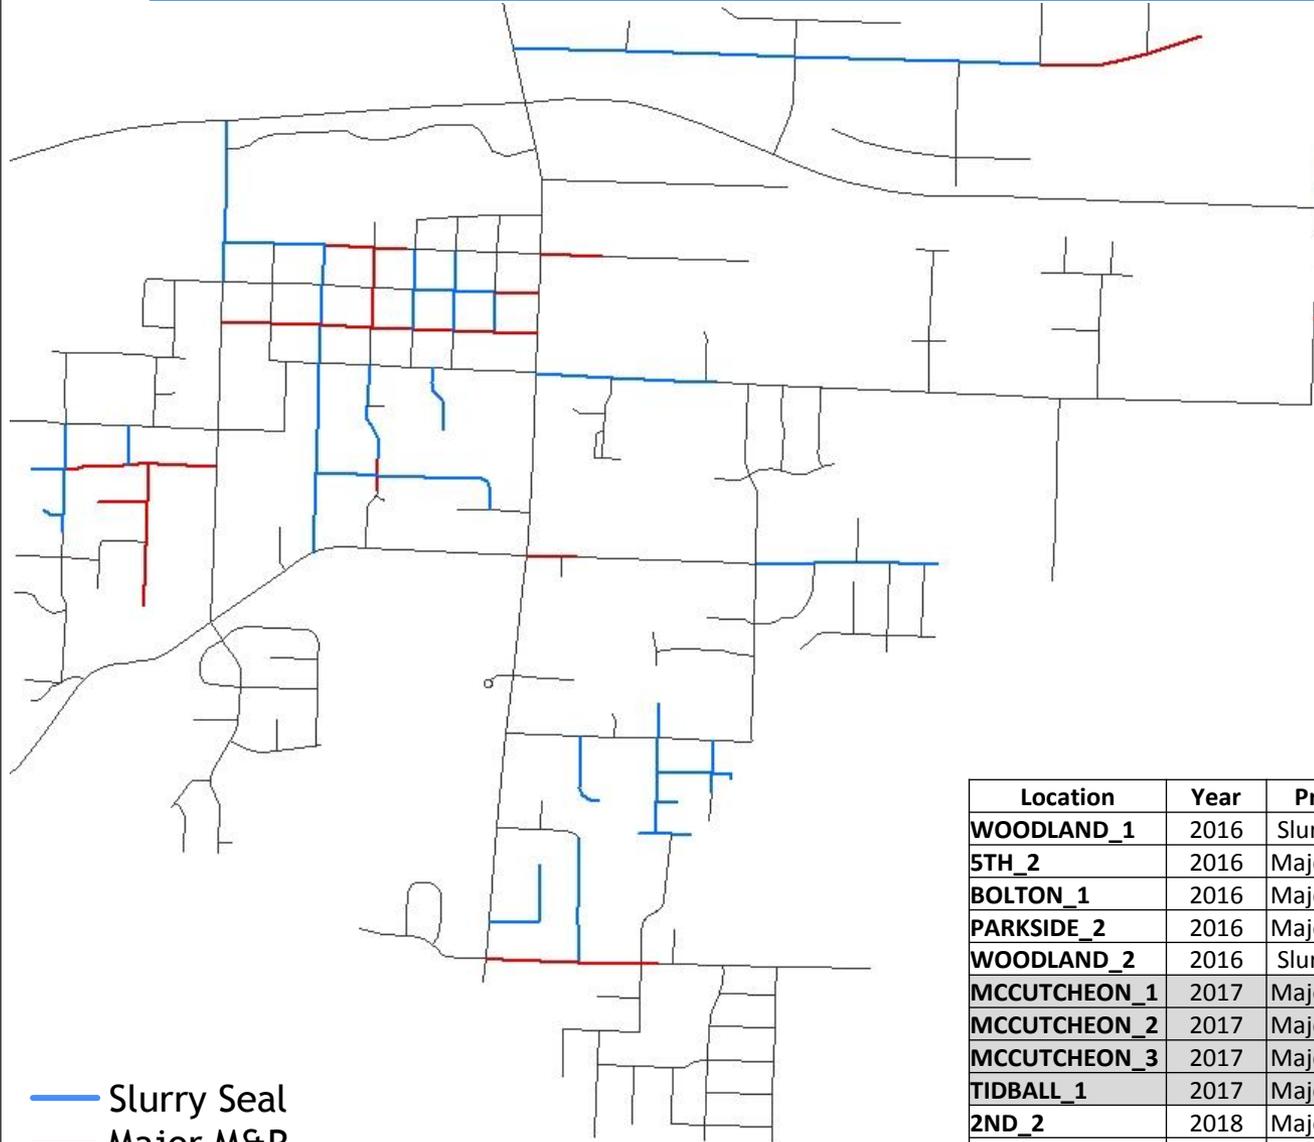
Project Development – Current Budget

— Slurry Seal
— Major M&R
