PROJECT REPORT

**Pavement Condition Index Survey &
Evaluation of the City of Veneta's Street Network**

Prepared For:
City of Veneta
88184 8th Street
Veneta, OR 97487

February 21, 2015

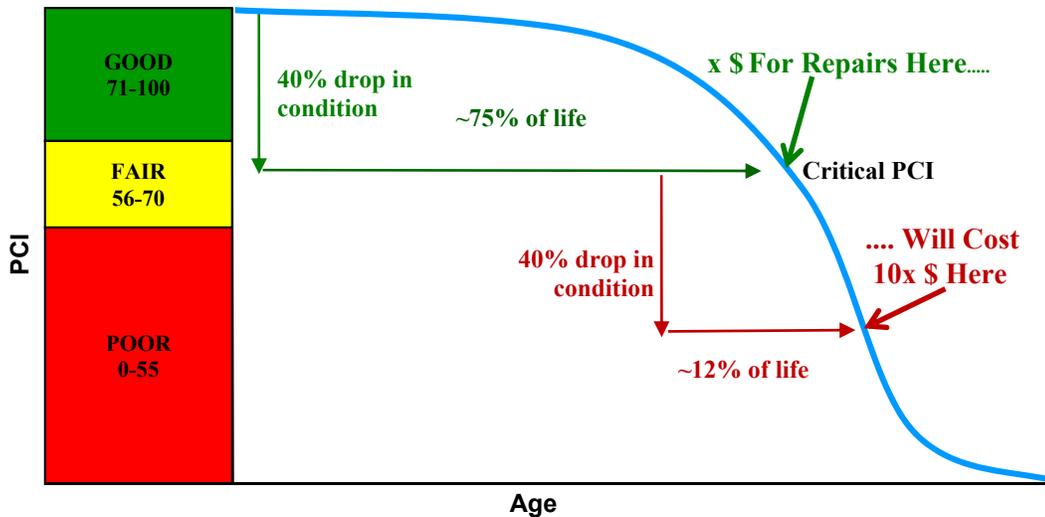
Figure 2 – Typical Pavement Deterioration Curve

Depending on design life and preventive maintenance, the typical pavement condition trend is for a slight deterioration right after construction and then the deterioration levels off. The leveling off period is where the deterioration condition slows relative to time. The period of slower deterioration is when the majority of the desired condition, use, and life of the pavement occurs. At the end of the "leveling off" period, there is a transition point referred to as the critical PCI. After the critical PCI is reached, the pavement condition typically deteriorates more quickly into a poor condition state. An example of typical pavement deterioration is presented in Figure 2.

Ideally, if preventive maintenance is performed before the critical PCI is reached, the life and use of the pavement can be extended in the leveling off period. Also, any major restoration work, such as overlay, that is done before a pavement deteriorates below the critical PCI usually costs substantially less than would be required if the rehabilitation work is delayed, due to the better condition of the pavement.

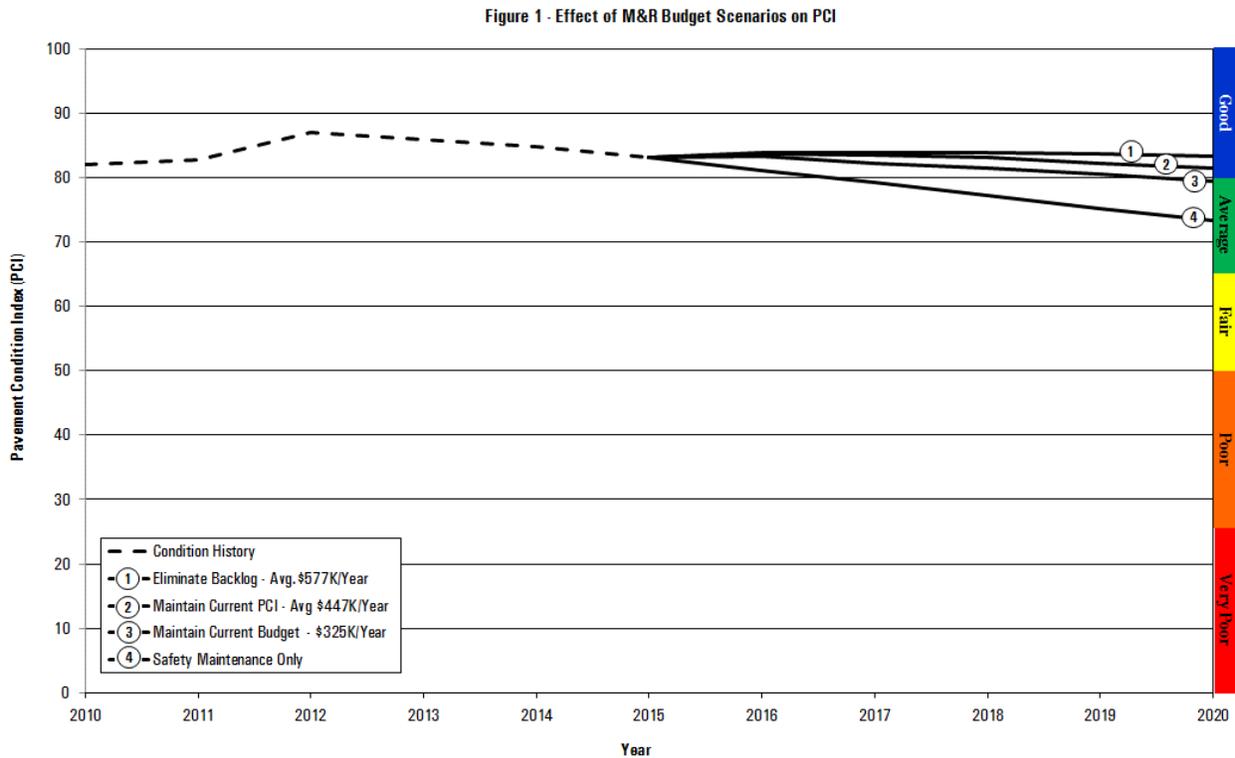
Figure 3 – Effects of Various Budget Scenarios on PCI

Figure 3 shows the effect of the four budget scenarios on the resulting condition of the Veneta street system.

Scenario 2. In order to stabilize the condition of the street system at the current PCI of 83, an annual budget of \$447K is required during the period of 2015-2020. At this level of investment, the unfunded M&R shrinks from \$2.70M to \$458K by year 2020.

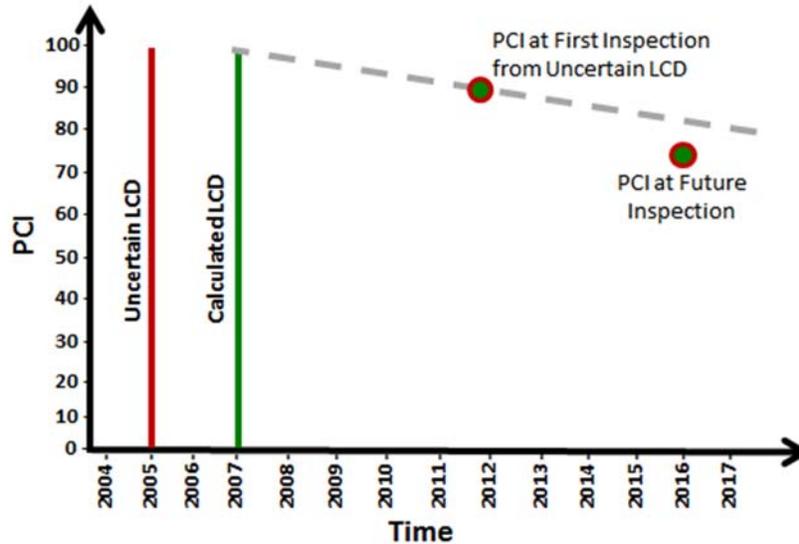
Figure 4. LCD Backcalculation Process.

The LCD backcalculation starts from the first inspection following the uncertain LCD, as shown in Figure 4. This is an example where a pavement with a PCI of 90 in 2012 would have a backcalculated LCD of 2007, assuming a condition deterioration rate of 2.0 PCI points/year and a PCI of 100 at the LCD.

For Veneta's LCD analysis, we used one deterioration rate of 2.0 points per year for all streets. The deterioration rate of 2.0 points/year was determined by establishing the deterioration rates of sections with known LCD. We also used a straight line deterioration model because the 2014 pavement condition index survey was the first PCI inspection for the Veneta street system. Once several PCI inspections have been conducted, the PAVER prediction modeling can use the actual deterioration patterns of pavements to determine the future condition. Models using the actual deterioration patterns of the pavements are developed when each pavement sections has multiple PCI and work history data points.

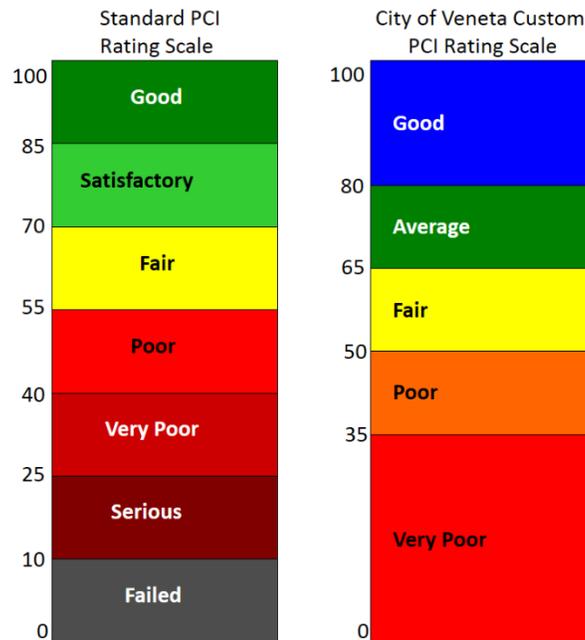
Figure 5. PCI Rating Scales

The average PCI of the Veneta street system was 83 on a scale of 0 to 100. Herein, the term average indicates area-weighted average unless otherwise specified. The standard rating scale defines seven PCI categories. This scale can be customized to have as many categories as desired in order to more easily view the distribution of PCI. For Veneta, we used a five-category scale as shown in Figure 5. Having five condition categories allows for quick observation of pavements that are in need of immediate repair (51 to 65), or which pavements have fallen into the worse category (0 to 50) and may require more costly repairs.

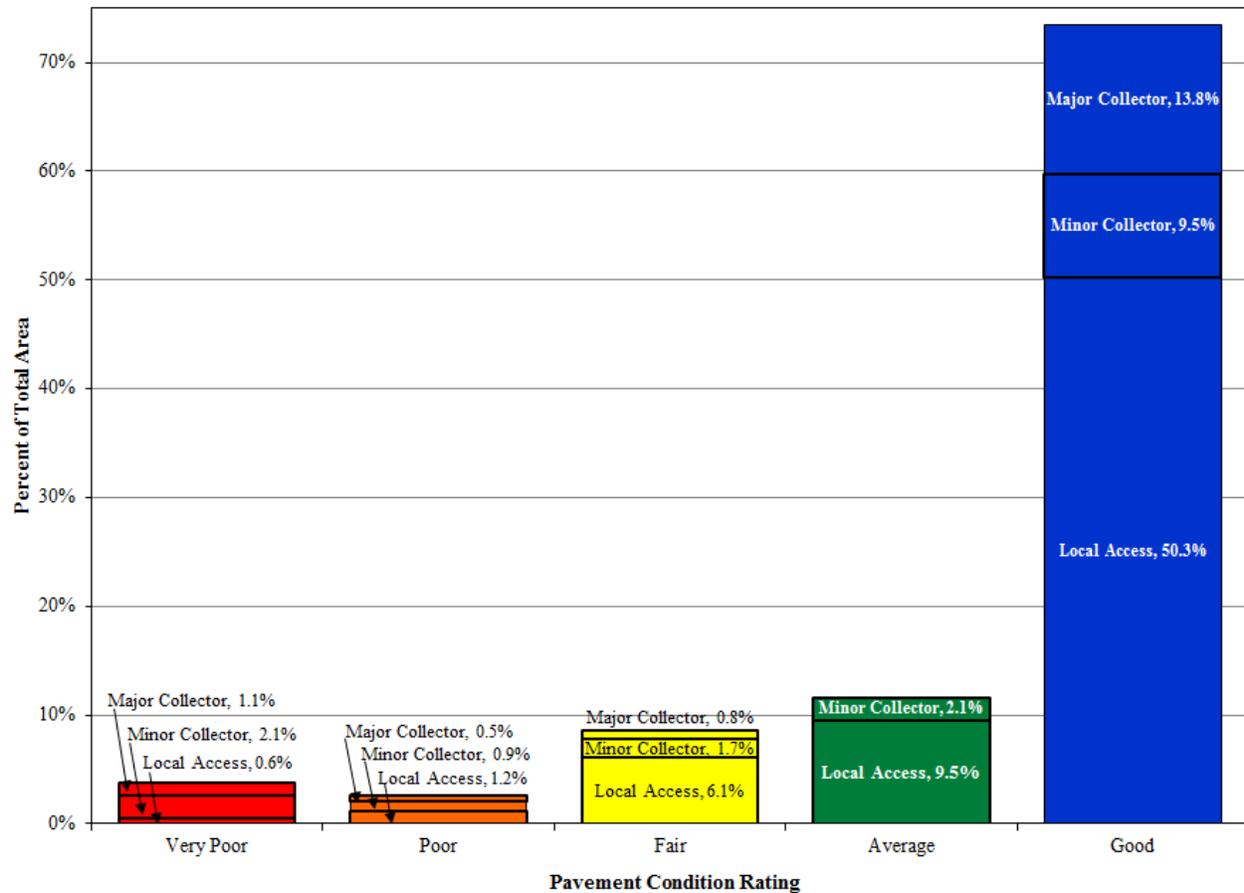
Figure 9. Overview of the Veneta Pavement Condition in 2014

Shown another way, Figure 9 presents the overall PCI distribution of the Veneta pavement network.

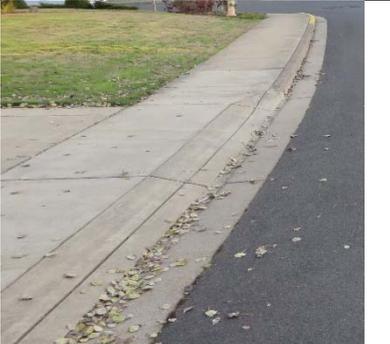
<p><u>Excellent Condition</u></p> <ul style="list-style-type: none"> • Uniform & Flat Cross Slope • No Slab Faulting • No Cracks • No Obstacles

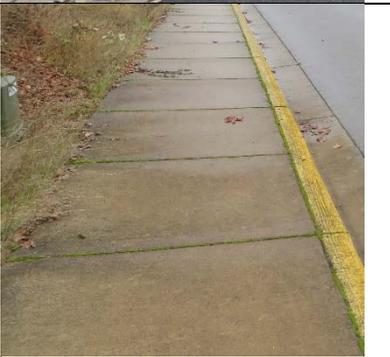
<p><u>Good Condition</u></p> <ul style="list-style-type: none"> • Uniform & Flat Cross Slope • No Slab Faulting • Minimal Cracks < 1/4" • No Obstacles

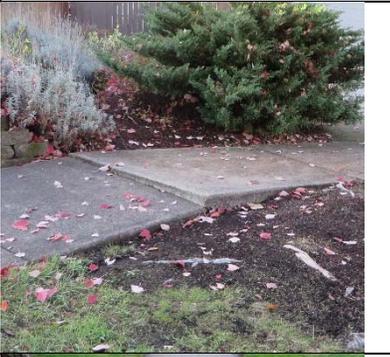
<p><u>Fair Condition</u></p> <ul style="list-style-type: none"> • Slightly Non-Uniform Cross Slope • Several Cracks > 1/4" • Several Faulted Slabs or Obstacles

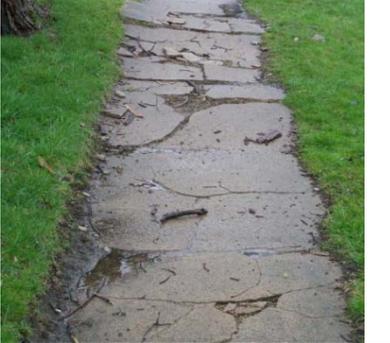
<p><u>Poor Condition</u></p> <ul style="list-style-type: none"> • Non-Uniform Cross Slope • Many Multi-Directional Cracks • Missing Pieces of Concrete • Significant Quantity of Faulted Slabs or Obstacles

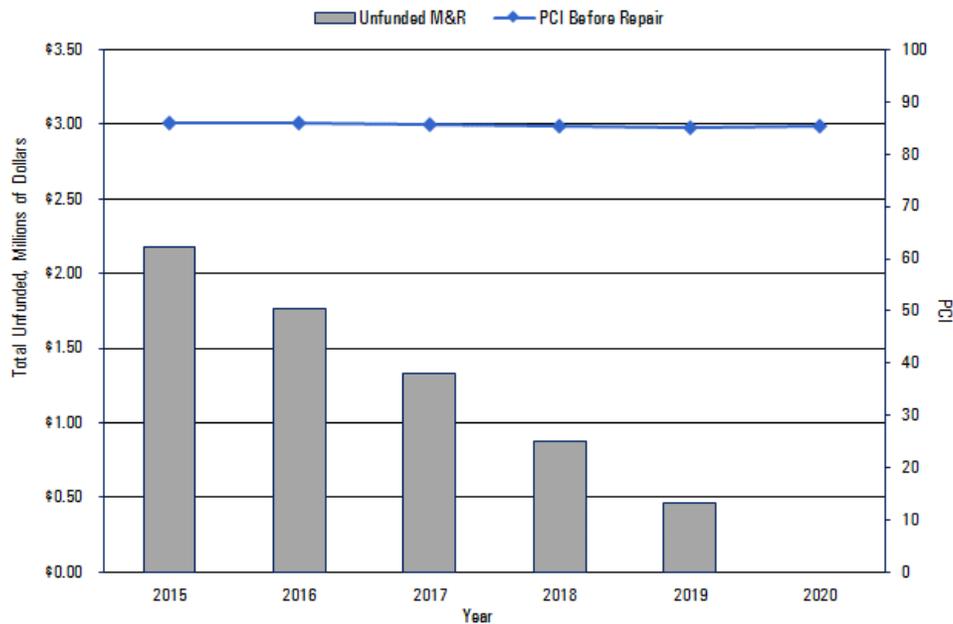
Figure 10–Scenario 1 Analysis Results

Due to the high overall PCI of Veneta's network, while the unfunded M&R is being eliminated, the PCI only increases slightly to 85 in 2020. The rate of PCI change can be compared to the rate of unfunded M&R decline in Figure 10.

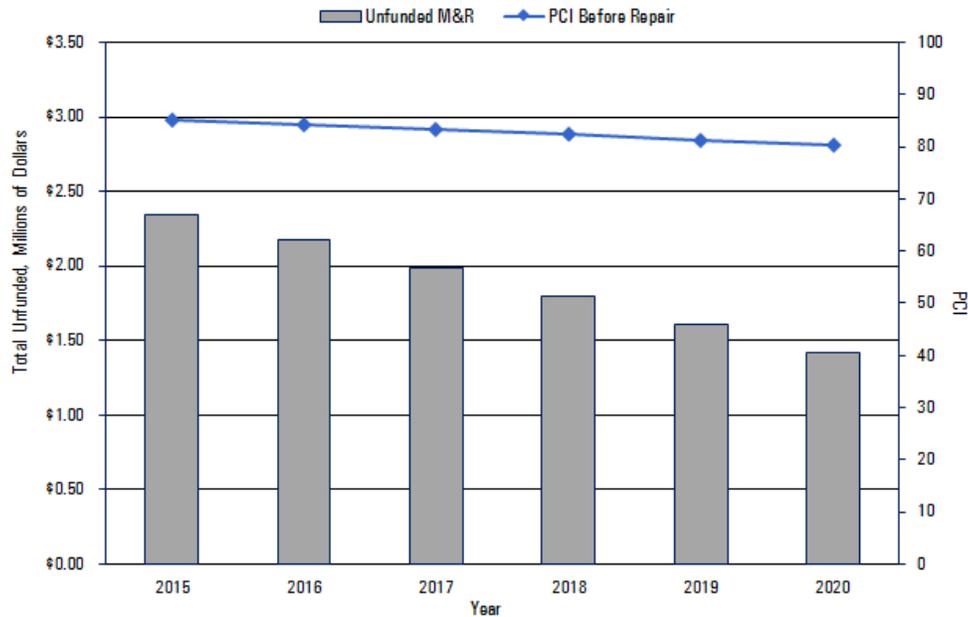
Figure 12–Scenario 3 Analysis Results

As shown in Figure 12, the total unfunded M&R decreases over the 6-year analysis period. However, when the analysis is carried out until 2030, the unfunded M&R decreases to \$891K in 2024. This unfunded M&R level holds steady for a couple years before it begins to increase. All the while, the PCI continues to decrease. This parabolic trend is due to the inability of the current annual budget to accommodate several of the larger rehabilitation projects, which if repaired would allow the unfunded M&R to continue to be reduced.

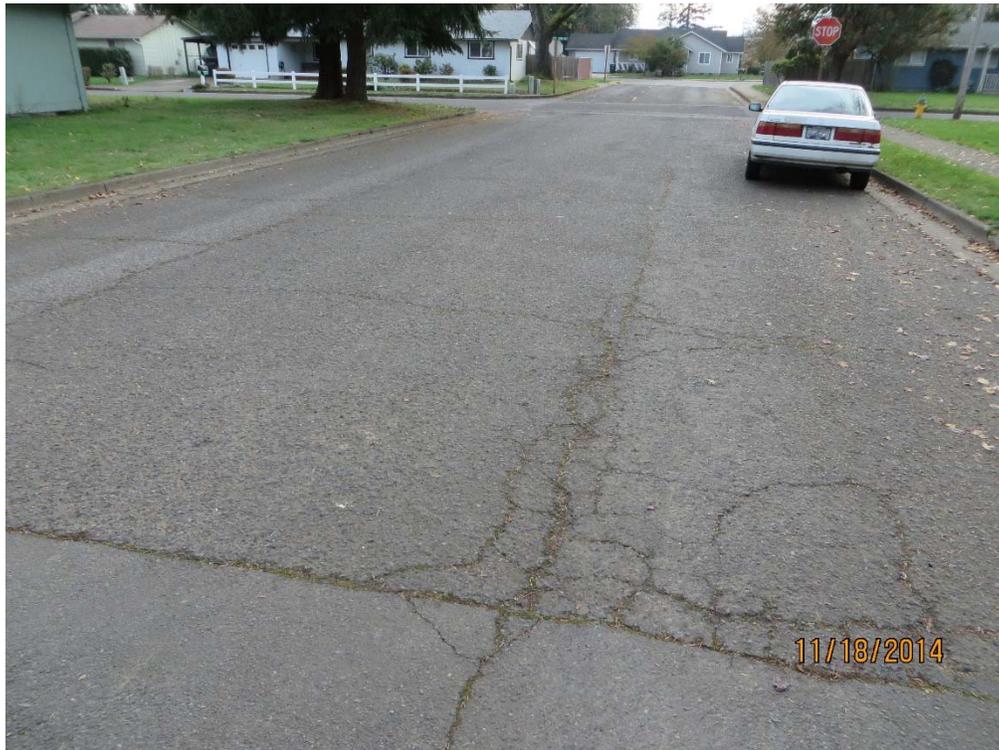
BranchID: 5TH
Name: 5th Street
SectionID: 5
From: Pavement Change near Woodland Ave
To: Bolton Hill Road
PCI Before Project: 54
PCI After Project: 100
Work Type: Mill & Overlay. Full depth patching.
Approximate Cost: \$22,887
Visual Distresses: Alligator Cracking, Longitudinal/Transverse Cracking, and Weathering

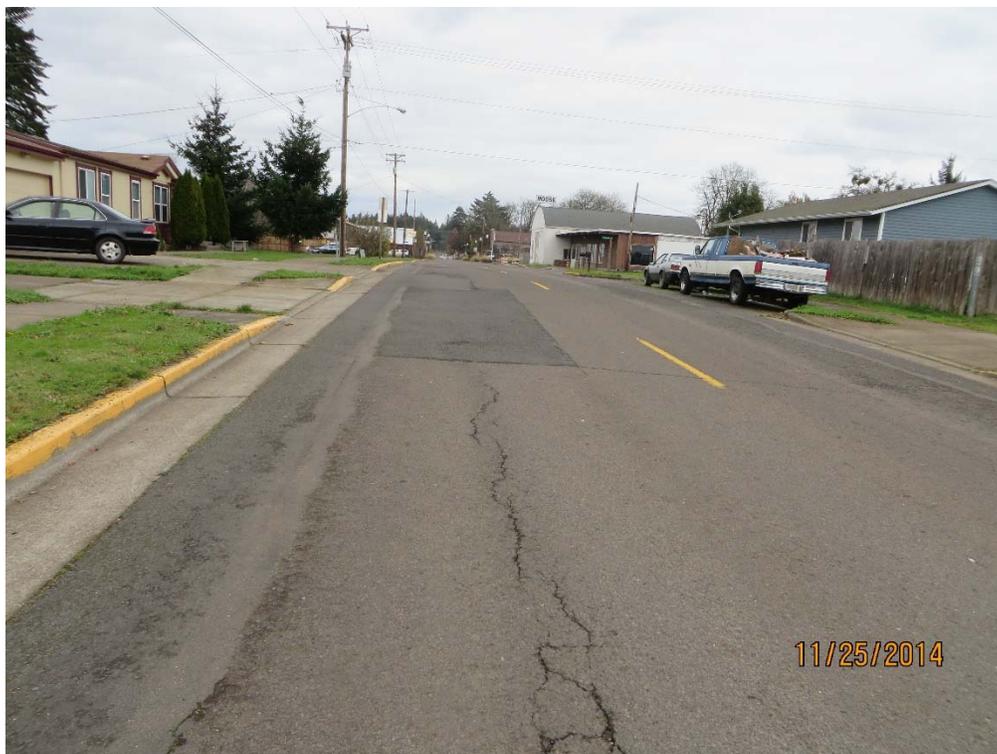
Street Name: BROADWAY
Name: Broadway Avenue
SectionID: 2
From: 6th Street
To: Pavement change near 4th Street
PCI Before Project: 76
PCI After Project: 100
Work Type: Mill & Overlay. Full depth patching.
Approximate Cost: \$35,509
Visual Distresses: Alligator Cracking, Longitudinal/Transverse Cracking, Patching,
and Weathering

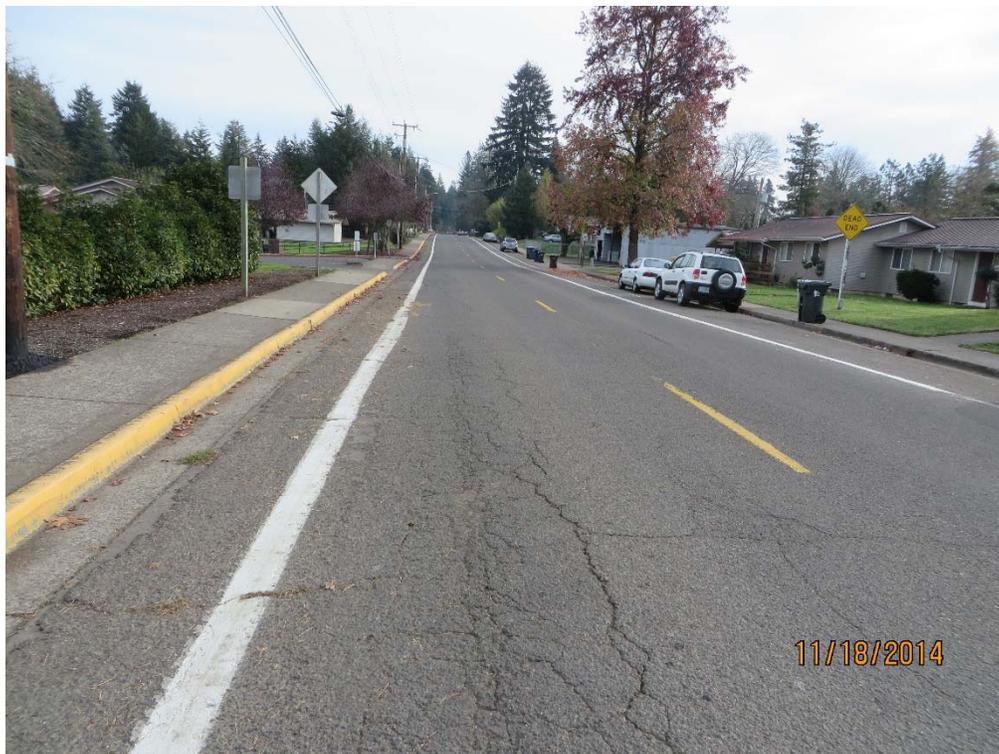
Street Name: BROADWAY
Name: Broadway Avenue
SectionID: 5
From: Territorial Road
To: Pavement change
PCI Before Project: 64
PCI After Project: 100
Work Type: Mill & Overlay. Full depth patching.
Approximate Cost: \$39,560
Visual Distresses: Alligator Cracking, Longitudinal/Transverse Cracking, and Weathering

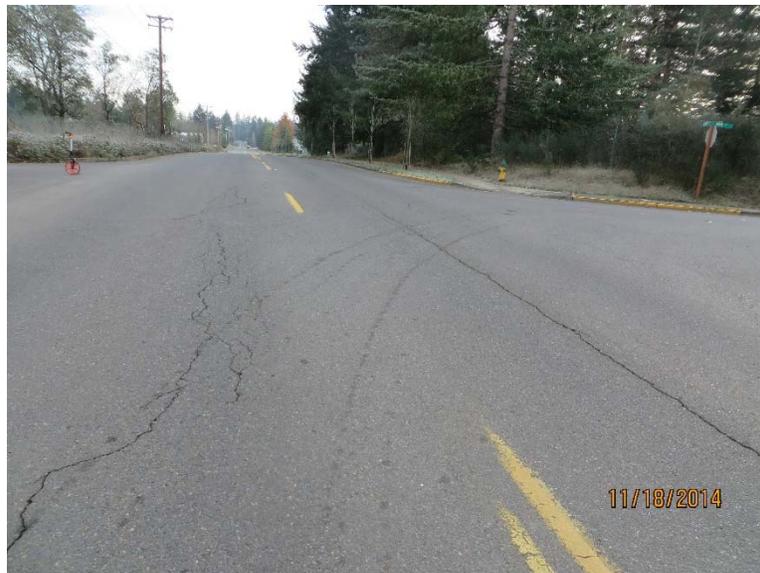
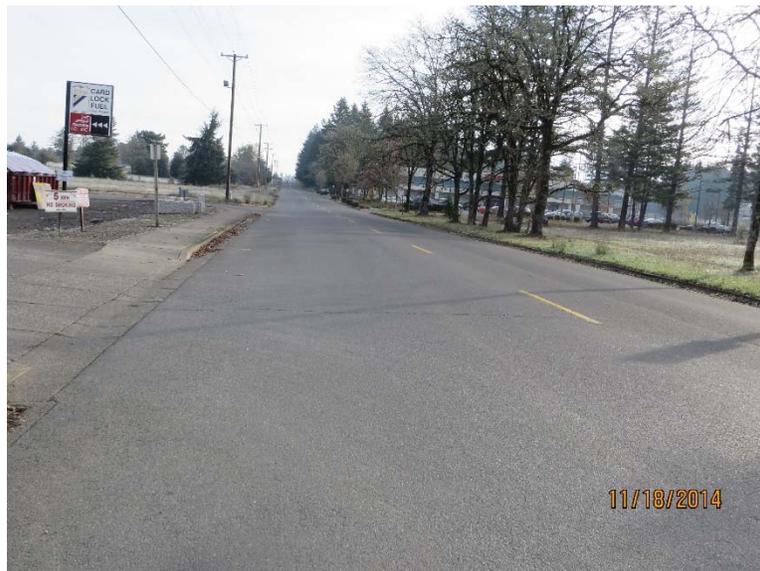
BranchID: JEANS
Name: Jeans Road
SectionID: 1
From: Territorial Road
To: Forest Meadows Lane
PCI Before Project: 86
PCI After Project: 96
Work Type: Slurry seal. Full depth patching, and crack sealing.
Approximate Cost: \$37,561
Visual Distresses: Alligator Cracking, Longitudinal/Transverse Cracking, and Weathering

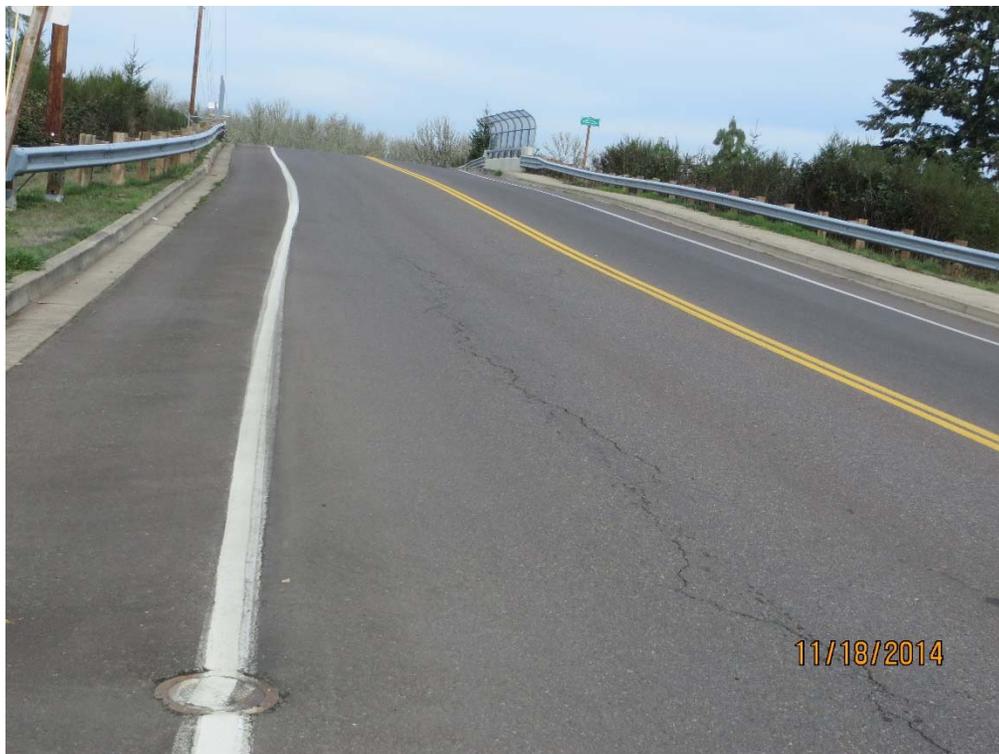
BranchID: 8TH
Name: 8th Street
SectionID: 1 & 2
From: Highway 126
To: Dunham Avenue
PCI Before Project: 83 & 76
PCI After Project: 88 & 82
Work Type: Slurry seal. Full depth patching and crack sealing.
Approximate Cost: \$13,040
Visual Distresses: Alligator Cracking, Longitudinal/Transverse Cracking, and Weathering

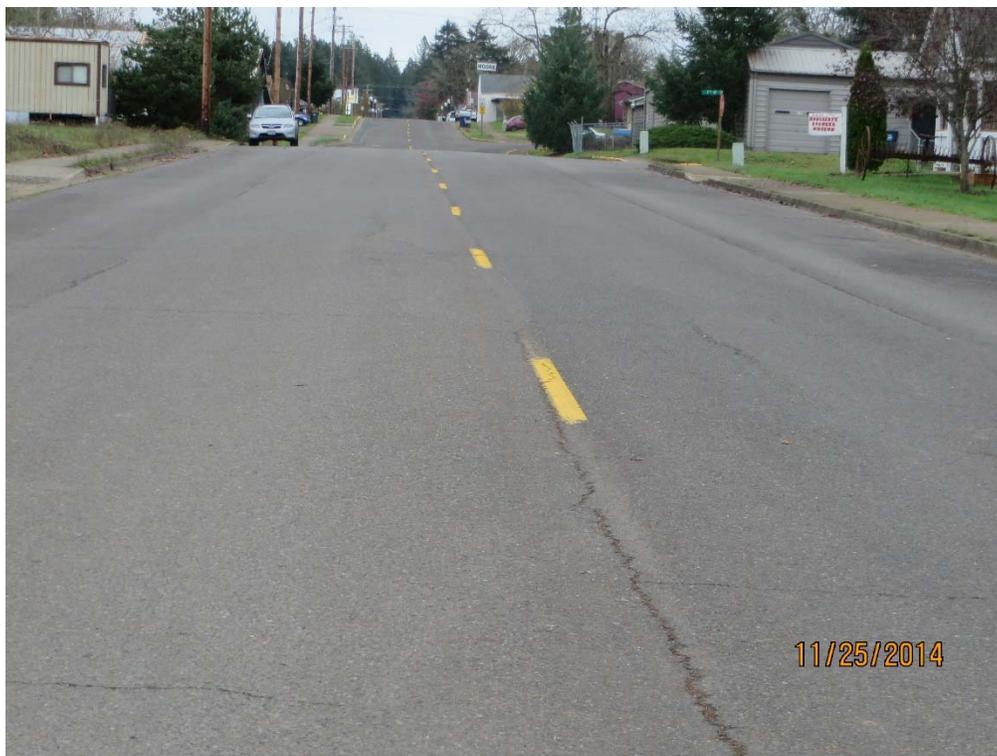
BranchID: BROADWAY
Name: Broadway Avenue
SectionID: 1
From: 8th Street
To: 6th Street
PCI Before Project: 76
PCI After Project: 82
Work Type: Slurry seal. Crack sealing.
Approximate Cost: \$8,856
Visual Distresses: Longitudinal/Transverse Cracking and Weathering

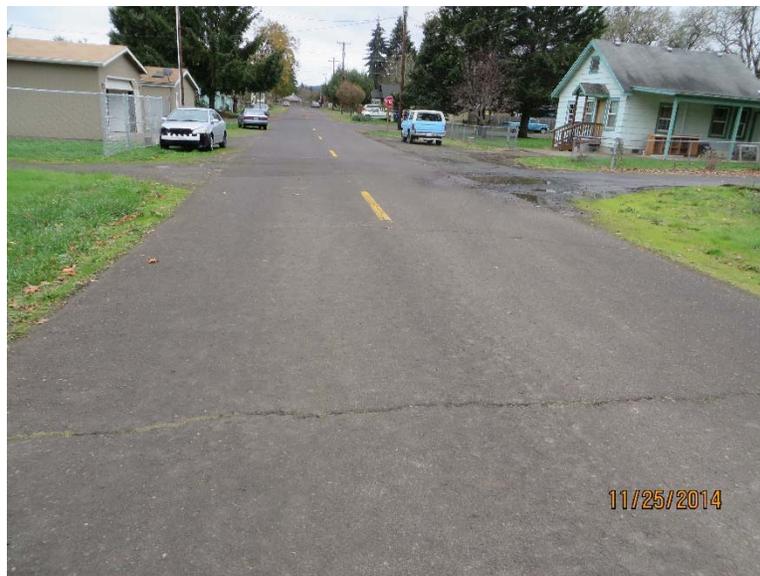
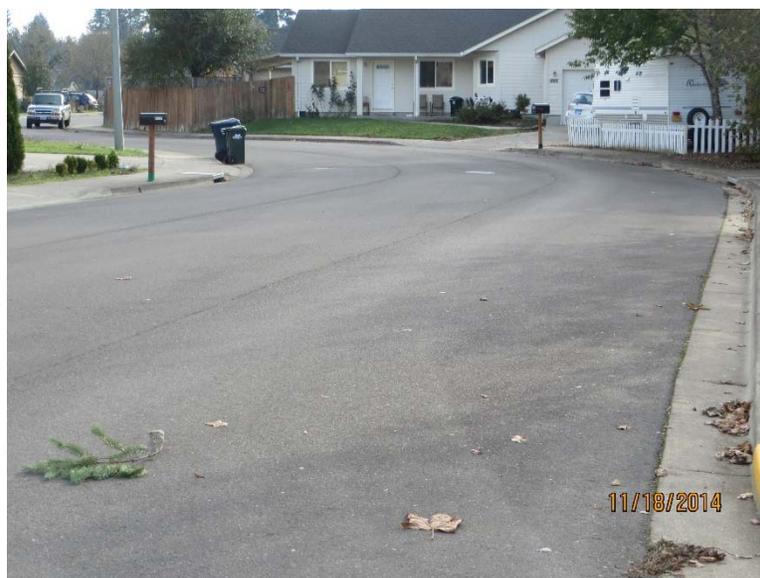
BranchID: 3RD
Name: 3rd Street
SectionID: 2, 3, & 5
From: Broadway Avenue
To: South Terminus
PCI Before Project: 68, 68, & 84
PCI After Project: 77, 77, & 93
Work Type: Slurry seal. Crack sealing.
Approximate Cost: \$8,653
Visual Distresses: Longitudinal/Transverse Cracking and Weathering

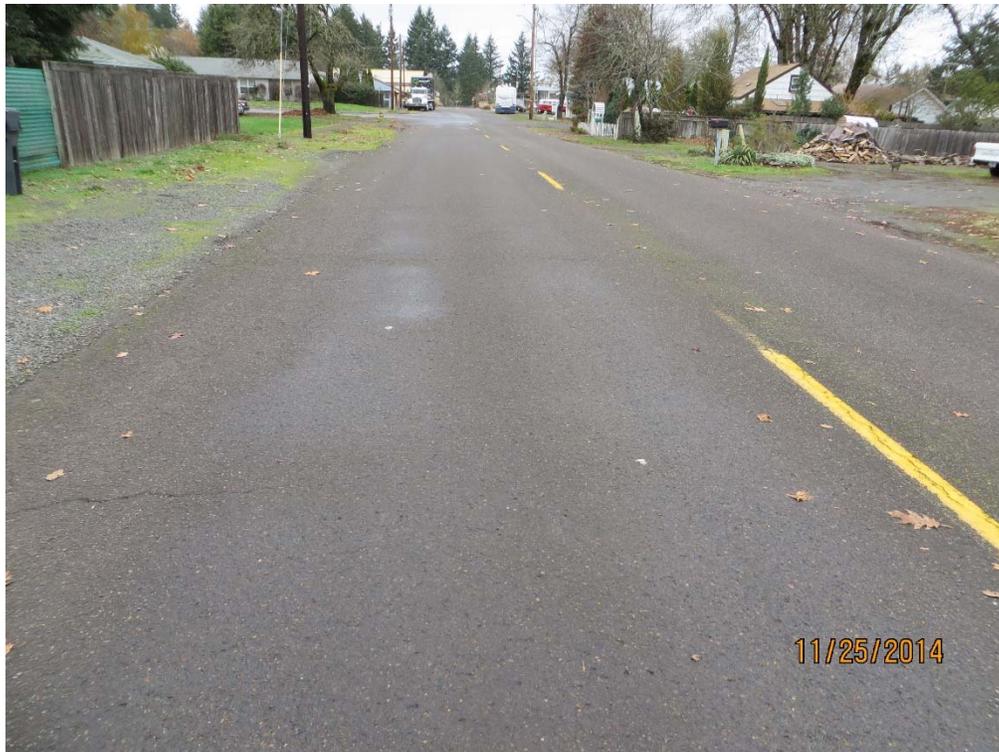
BranchID: 4TH
Name: 4th Street
SectionID: 2
From: Broadway Avenue
To: McCutcheon Avenue
PCI Before Project: 79
PCI After Project: 88
Work Type: Slurry seal. Crack sealing.
Approximate Cost: \$4,788
Visual Distresses: Alligator Cracking, Longitudinal/Transverse Cracking and Weathering

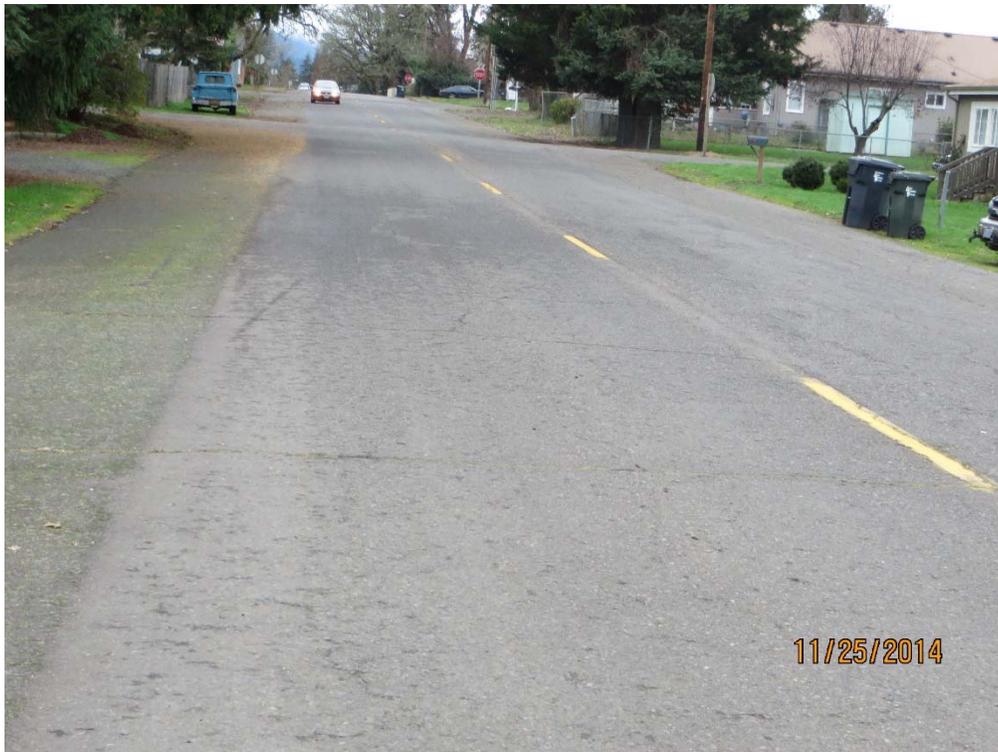
BranchID: DUNHAM
Name: Dunham Avenue
SectionID: 5
From: 4th Street
To: 2nd Street
PCI Before Project: 69
PCI After Project: 78
Work Type: Slurry seal. Crack sealing.
Approximate Cost: \$7,011
Visual Distresses: Longitudinal/Transverse Cracking and Weathering

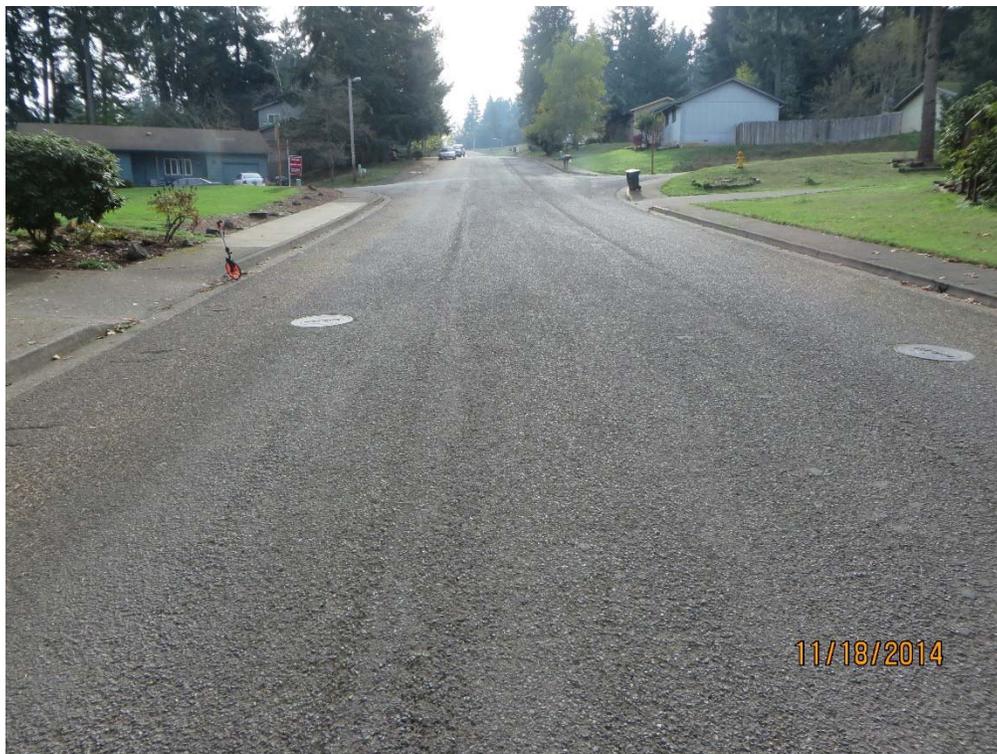
BranchID: 10TH
Name: 10th Street
SectionID: 2
From: Sertic Road
To: Pavement Change near Forest Court
PCI Before Project: 65
PCI After Project: 74
Work Type: Slurry Seal. Crack sealing.
Approximate Cost: \$7,951
Visual Distresses: Longitudinal/Transverse Cracking and Weathering

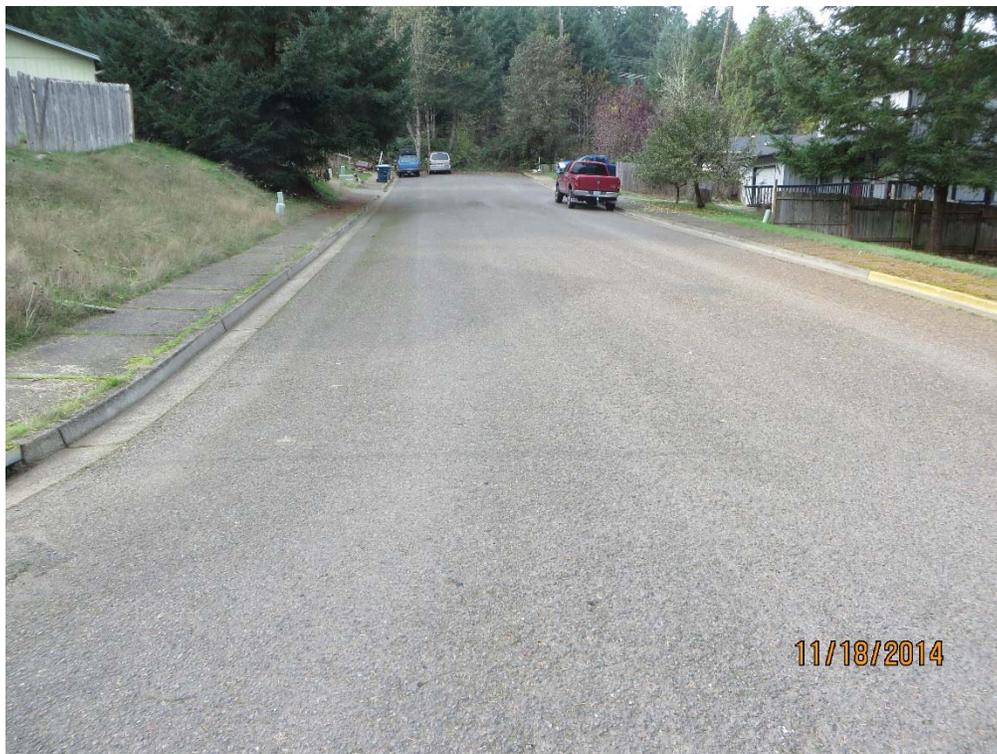
BranchID: PARKSIDE
Name: Parkside Drive
SectionID: 1
From: West Terminus
To: 10th Street
PCI Before Project: 61
PCI After Project: 70
Work Type: Slurry Seal. Crack sealing.
Approximate Cost: \$2,140
Visual Distresses: Longitudinal/Transverse Cracking and Weathering

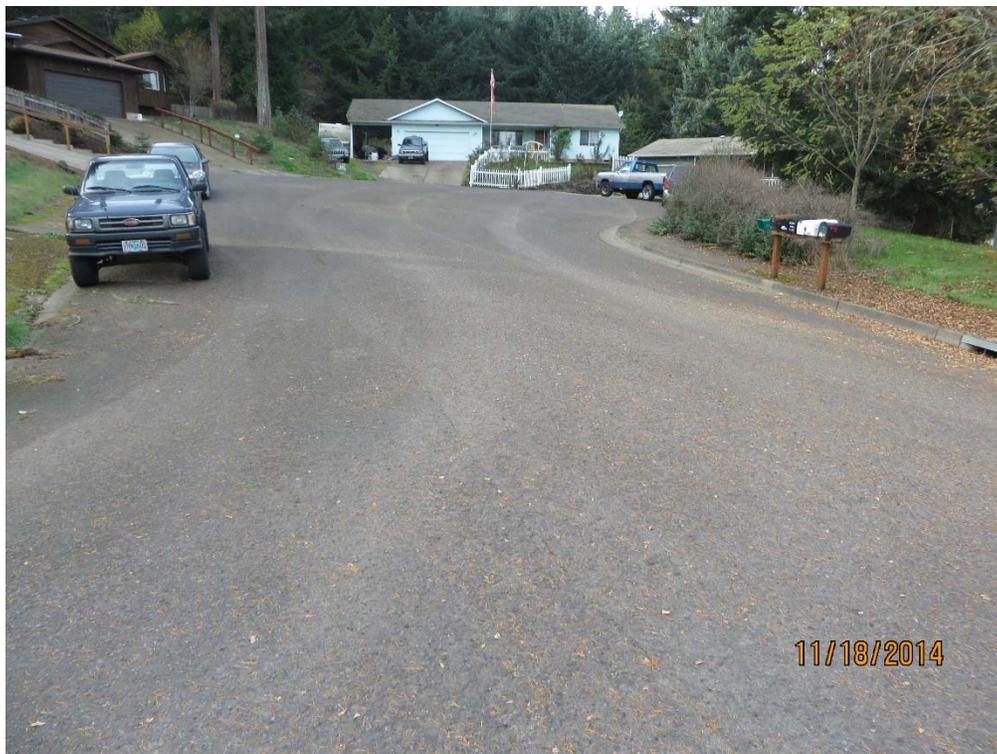
BranchID: FOREST
Name: Forest Court
SectionID: 1
From: West Terminus
To: 10th Street
PCI Before Project: 60
PCI After Project: 69
Work Type: Slurry Seal. Crack sealing.
Approximate Cost: \$1,582
Visual Distresses: Longitudinal/Transverse Cracking and Weathering

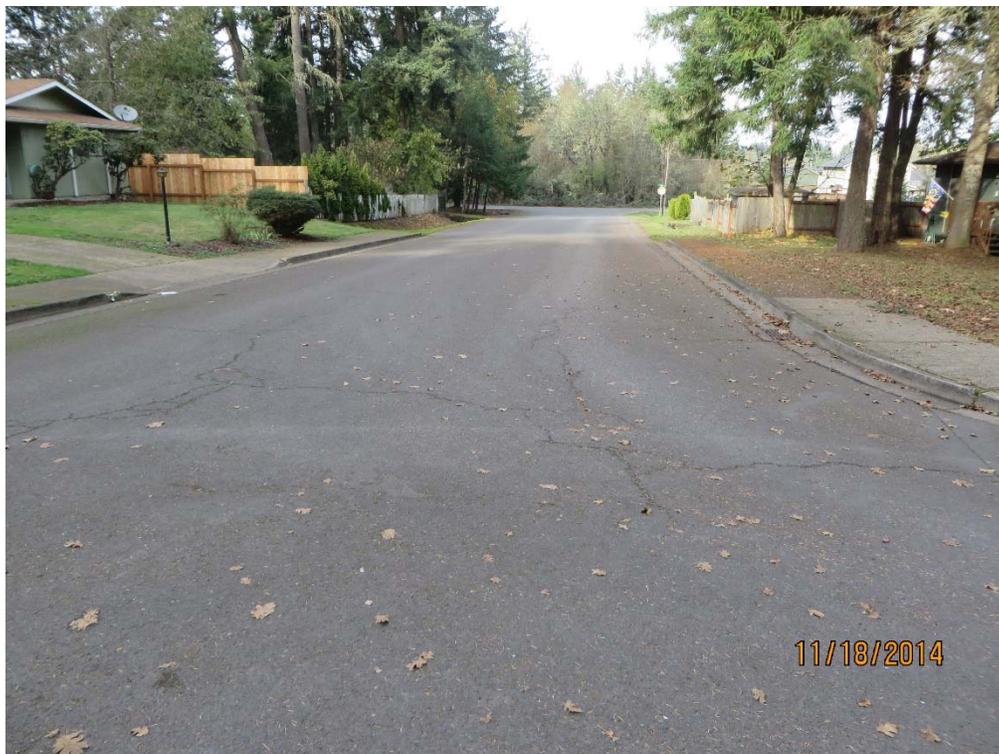
BranchID: 9TH
Name: 9th Street
SectionID: 4
From: Sertic Road
To: Parkside Drive
PCI Before Project: 74
PCI After Project: 73
Work Type: Slurry Seal. Crack sealing.
Approximate Cost: \$2,611
Visual Distresses: Longitudinal/Transverse Cracking and Weathering

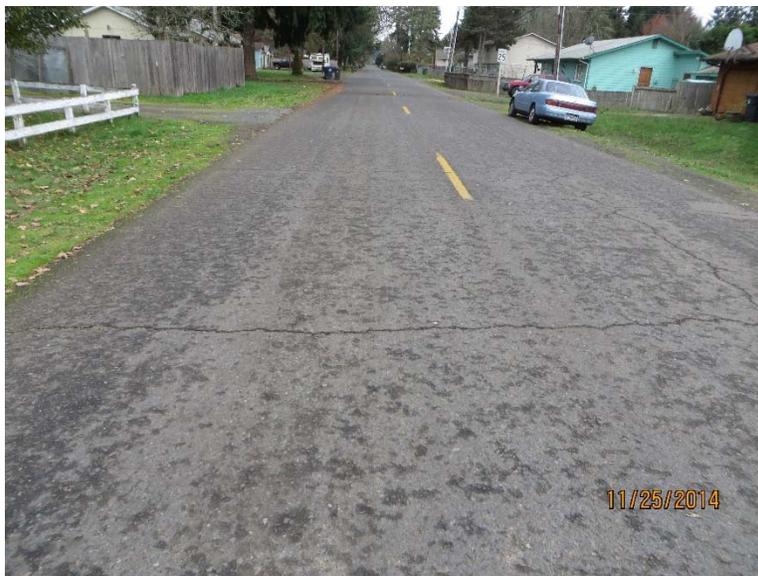
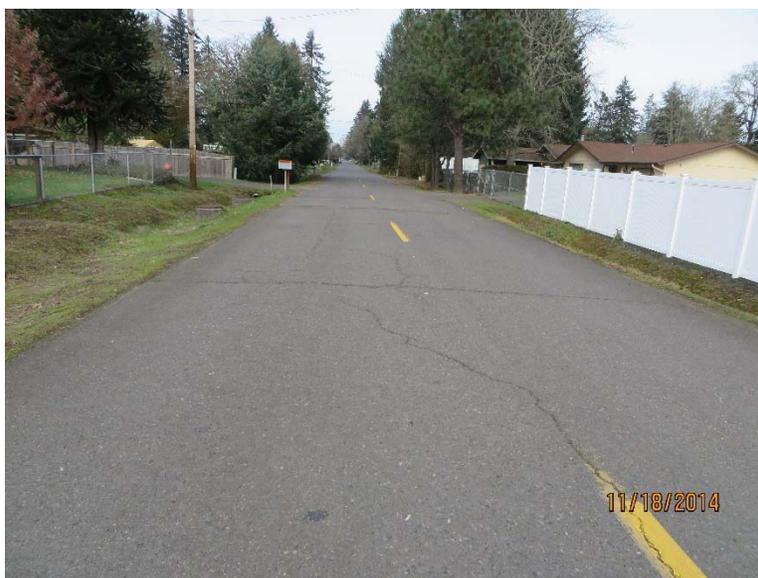
BranchID: 6TH
Name: 6th Street
SectionID: 1, 2, & 3
From: Broadway Avenue
To: Bolton Hill Road
PCI Before Project: 68, 92 & 70
PCI After Project: 78, 96 & 79
Work Type: Slurry Seal. Crack sealing.
Approximate Cost: \$17,819
Visual Distresses: Longitudinal/Transverse Cracking and Weathering

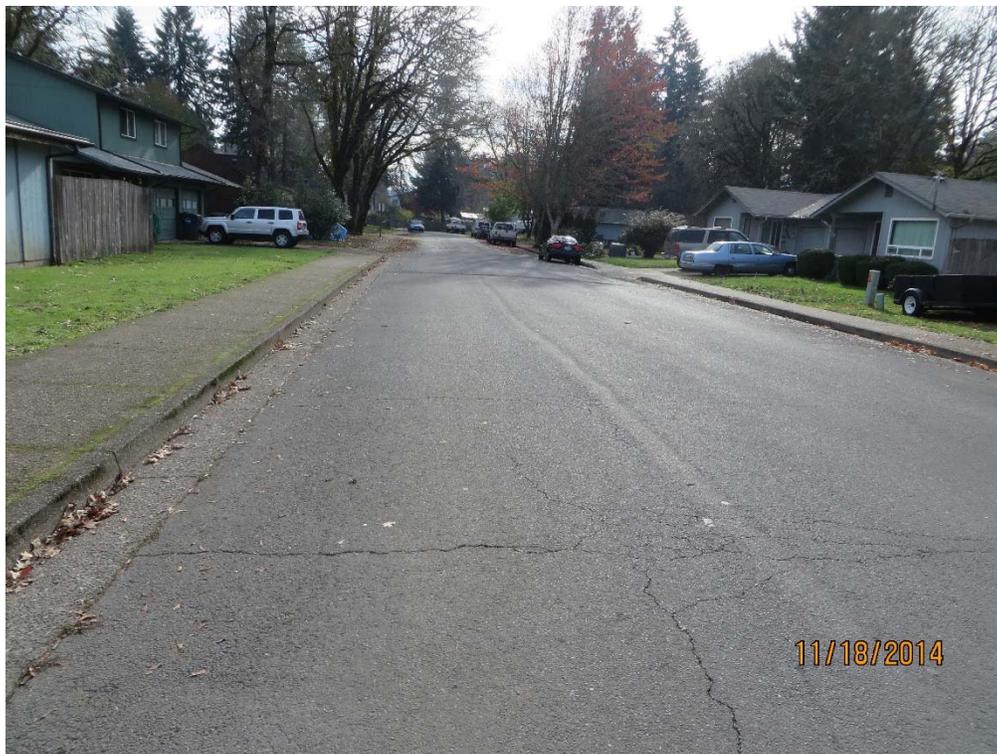
BranchID: 5TH
Name: 5th Street
SectionID: 4
From: Hunter Road
To: Pavement change near Woodland Avenue
PCI Before Project: 80
PCI After Project: 89
Work Type: Slurry Seal. Crack sealing. Full depth patching
Approximate Cost: \$6,195
Visual Distresses: Alligator Cracking, Longitudinal/Transverse Cracking and Weathering

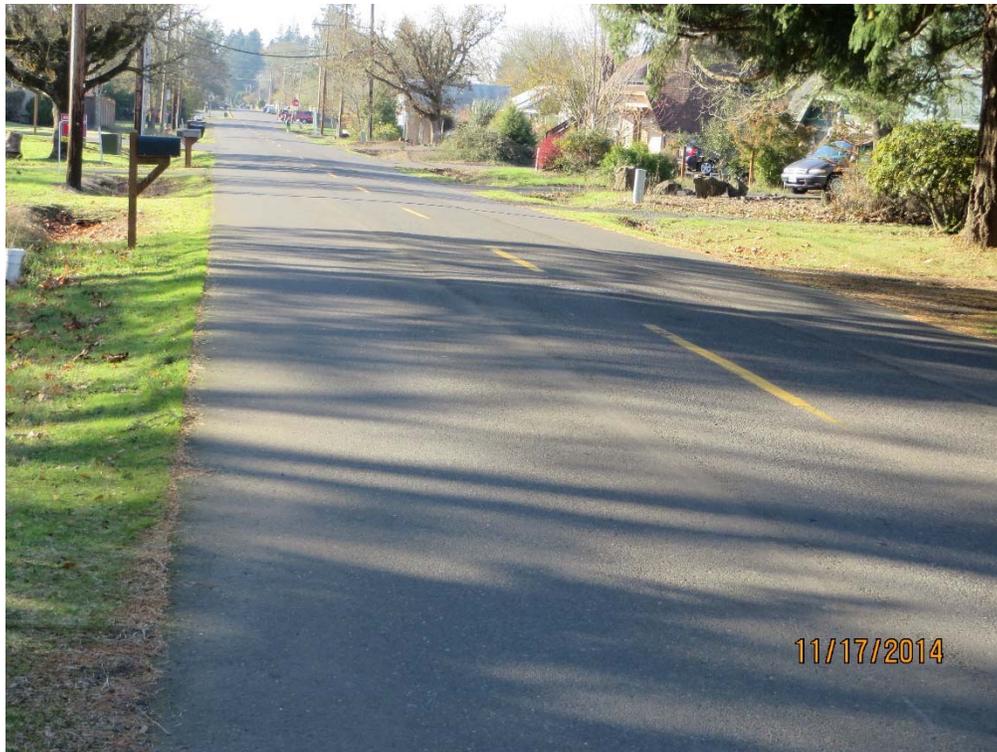
BranchID: HUNTER
Name: Hunter Road
SectionID: 4
From: Territorial Road
To: Pavement change near Ruby Jean Lane
PCI Before Project: 86
PCI After Project: 96
Work Type: Slurry Seal. Crack sealing. Shoulder leveling
Approximate Cost: \$8,544
Visual Distresses: Lane Shoulder Drop Off, Longitudinal/Transverse Cracking and Weathering

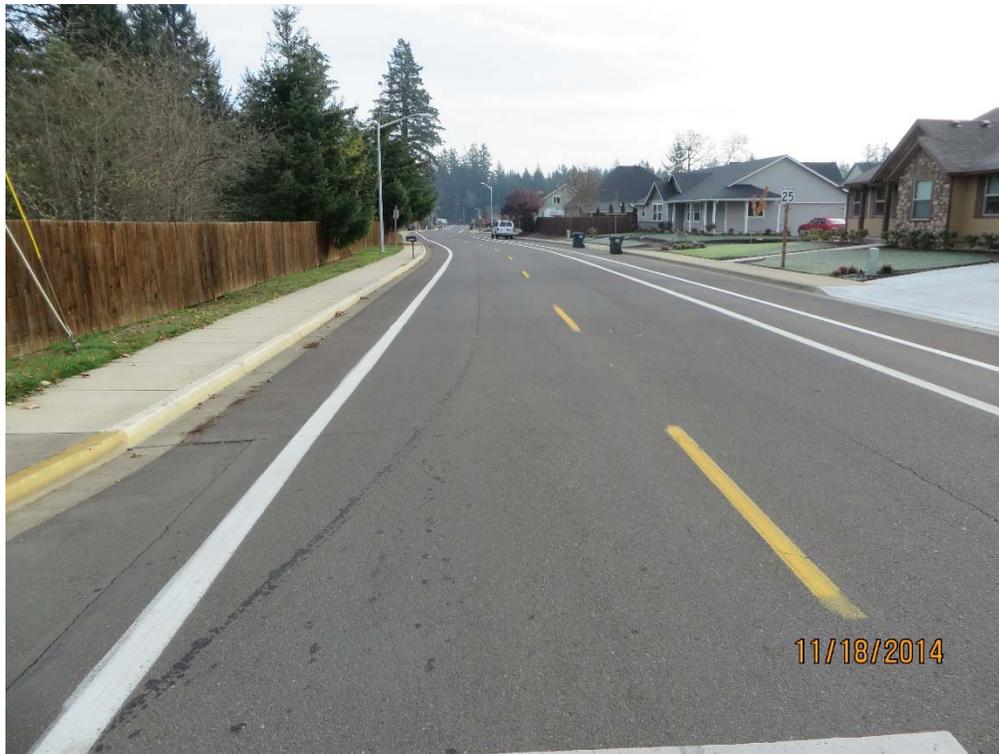
BranchID: TRINITY
Name: Trinity Street
SectionID: 1
From: E Bolton Road
To: Longwood Lane
PCI Before Project: 88
PCI After Project: 94
Work Type: Slurry Seal. Crack sealing.
Approximate Cost: \$13,793
Visual Distresses: Longitudinal/Transverse Cracking and Weathering

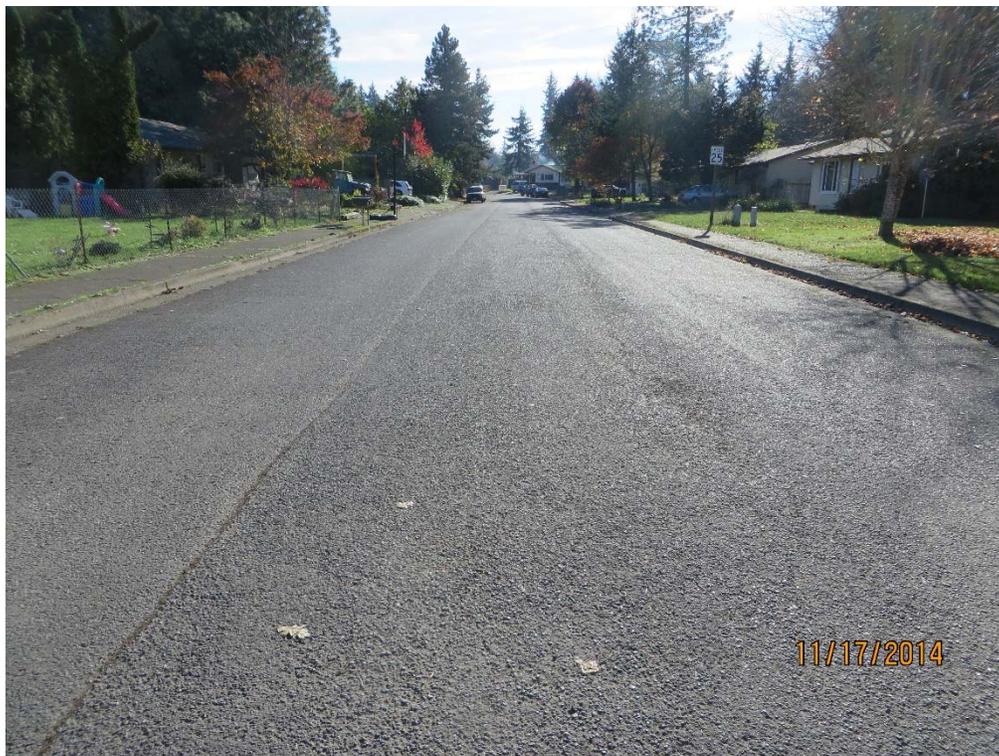
BranchID: NORMAN
Name: Norman Avenue
SectionID: 1
From: Cheney Drive
To: South Terminus
PCI Before Project: 78
PCI After Project: 87
Work Type: Slurry Seal. Crack sealing.
Approximate Cost: \$4,907
Visual Distresses: Longitudinal/Transverse Cracking and Weathering

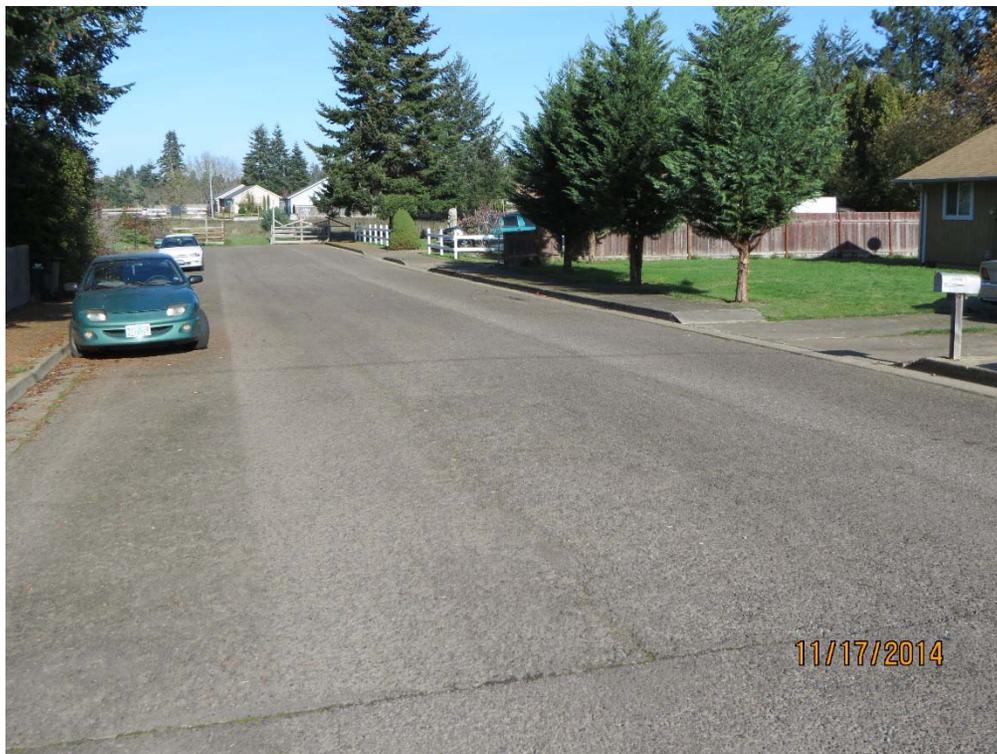
BranchID: OAK ISLAND
Name: Oak Island Drive
SectionID: 2 & 3
From: North Terminus
To: Cherry Lane
PCI Before Project: 48 & 78
PCI After Project: 57 & 87
Work Type: Slurry Seal. Crack sealing.
Approximate Cost: \$8,322
Visual Distresses: Longitudinal/Transverse Cracking and Weathering
