PROJECT REPORT

**Pavement Condition Index Survey &
Evaluation of the City of Veneta's Street Network**

Prepared For:
City of Veneta
88184 8th Street
Veneta, OR 97487

February 21, 2015

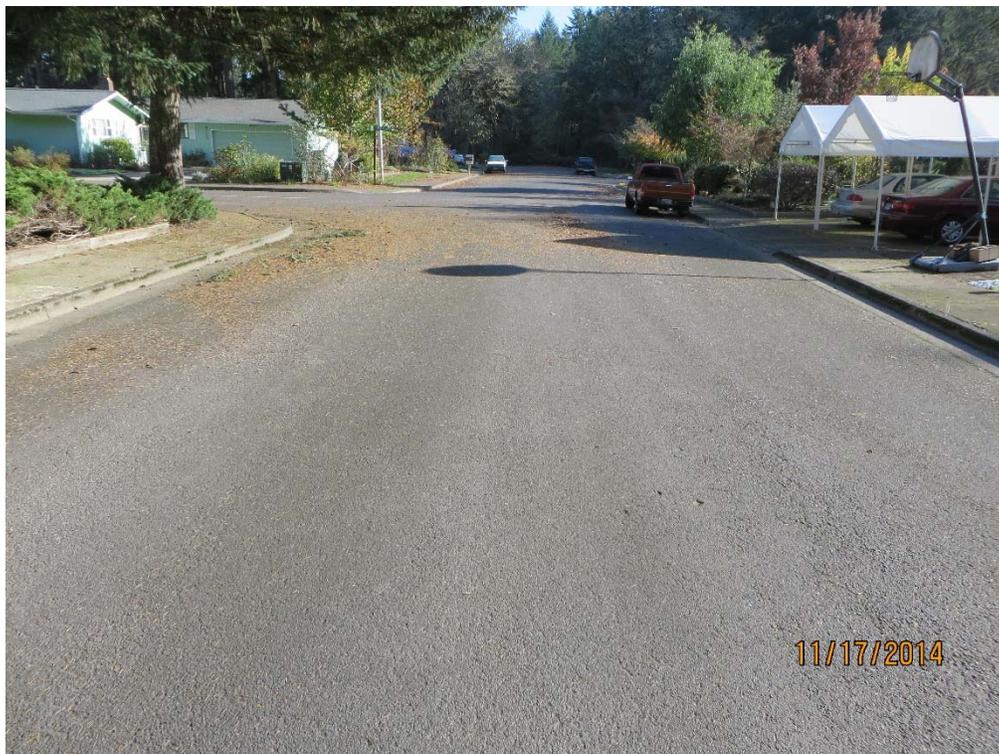
BranchID: CHERRY
Name: Cherry Lane
SectionID: 1
From: West Terminus
To: East Terminus
PCI Before Project: 78
PCI After Project: 87
Work Type: Slurry Seal. Crack sealing.
Approximate Cost: \$33,01
Visual Distresses: Longitudinal/Transverse Cracking and Weathering

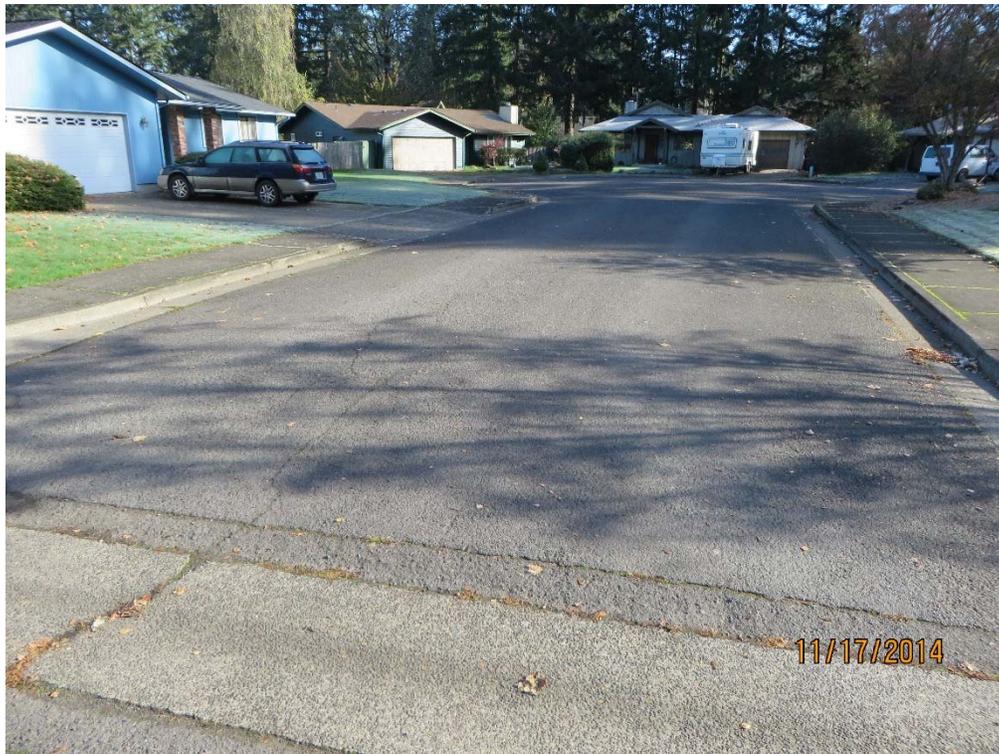
BranchID: ACORN
Name: Acorn Court
SectionID: 1
From: Oak Island Drive
To: East Terminus
PCI Before Project: 71
PCI After Project: 80
Work Type: Slurry Seal. Crack sealing.
Approximate Cost: \$1,545
Visual Distresses: Longitudinal/Transverse Cracking and Weathering

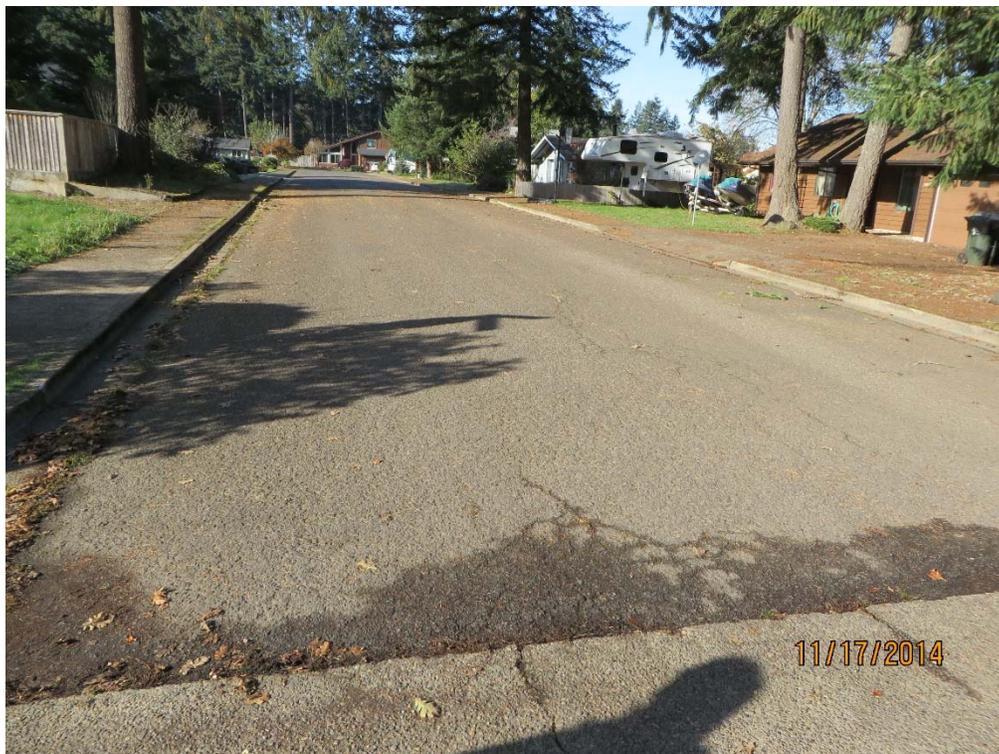
BranchID: BERRY
Name: Berry Lane
SectionID: 1 & 2
From: Oak Island Drive
To: Ponderosa Drive
PCI Before Project: 68 & 60
PCI After Project: 77 & 70
Work Type: Slurry Seal. Crack sealing.
Approximate Cost: \$5,242
Visual Distresses: Longitudinal/Transverse Cracking and Weathering

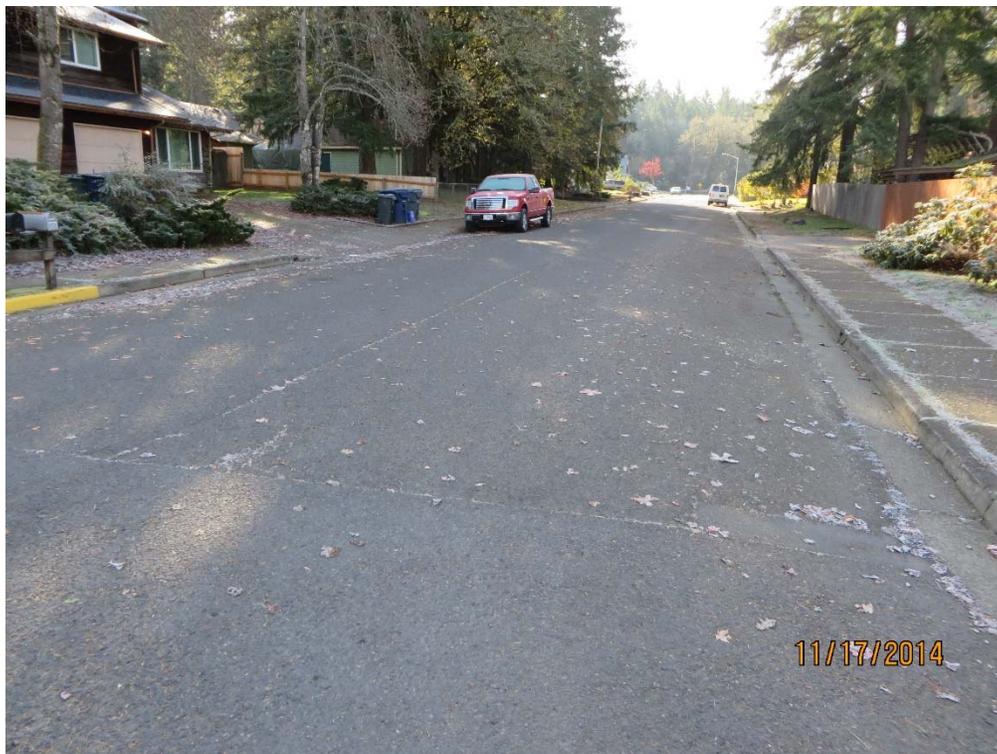
BranchID: PONDEROSA
Name: Ponderosa Drive
SectionID: 1
From: Cheney Drive
To: Pavement Change
PCI Before Project: 58
PCI After Project: 67
Work Type: Slurry Seal. Crack sealing.
Approximate Cost: \$3,291
Visual Distresses: Longitudinal/Transverse Cracking and Weathering

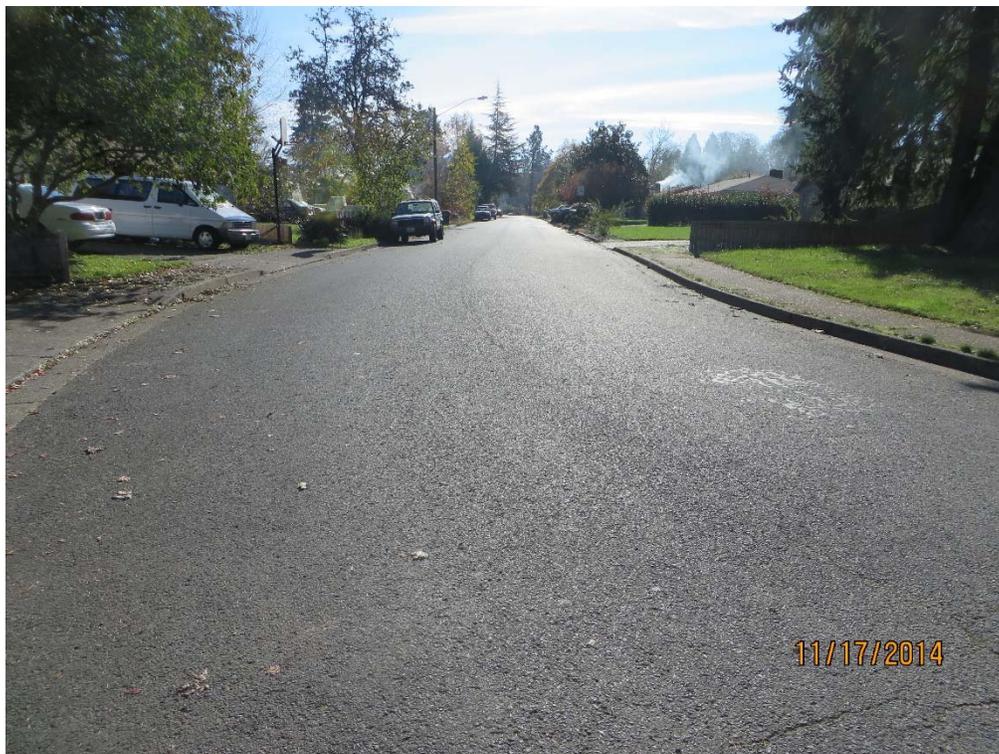
BranchID: BLEK
Name: Blek Drive
SectionID: 2
From: Pavement Change
To: Perkins Drive
PCI Before Project: 83
PCI After Project: 92
Work Type: Slurry Seal. Crack sealing.
Approximate Cost: \$6,791
Visual Distresses: Longitudinal/Transverse Cracking, Patching, and Weathering

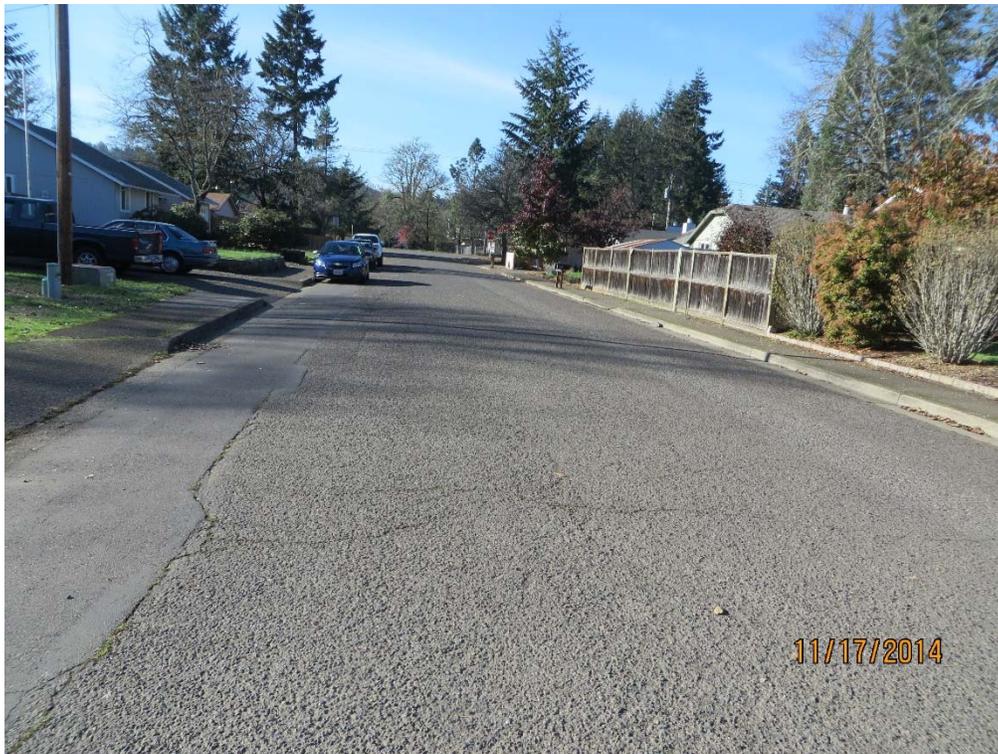
BranchID: TERRITORIAL
Name: Territorial Court
SectionID: 1
From: Territorial Road
To: North Terminus
PCI Before Project: 59
PCI After Project: 68
Work Type: Slurry Seal. Crack sealing.
Approximate Cost: \$6,737
Visual Distresses: Longitudinal/Transverse Cracking, Patching, and Weathering

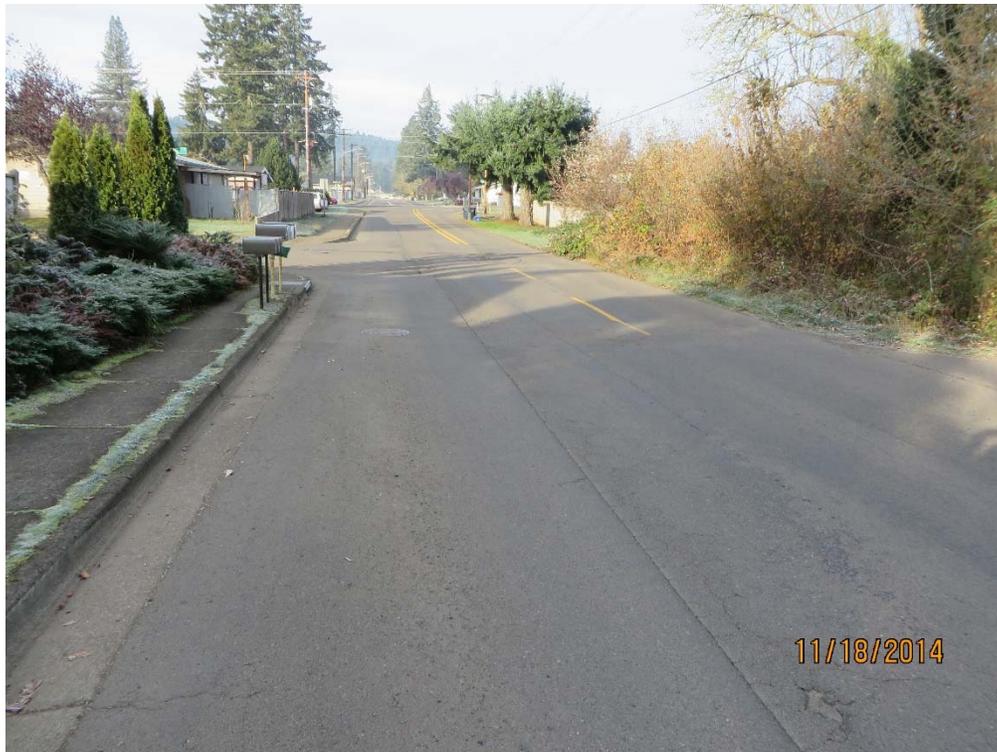
BranchID: BOLTON
Name: Bolton Road
SectionID: 1
From: Territorial Street
To: East at end of sidewalk
PCI Before Project: 23
PCI After Project: 100
Work Type: Reconstruction.
Approximate Cost: \$61,024
Visual Distresses: Alligator Cracking, Longitudinal/Transverse Cracking, Patching and Weathering

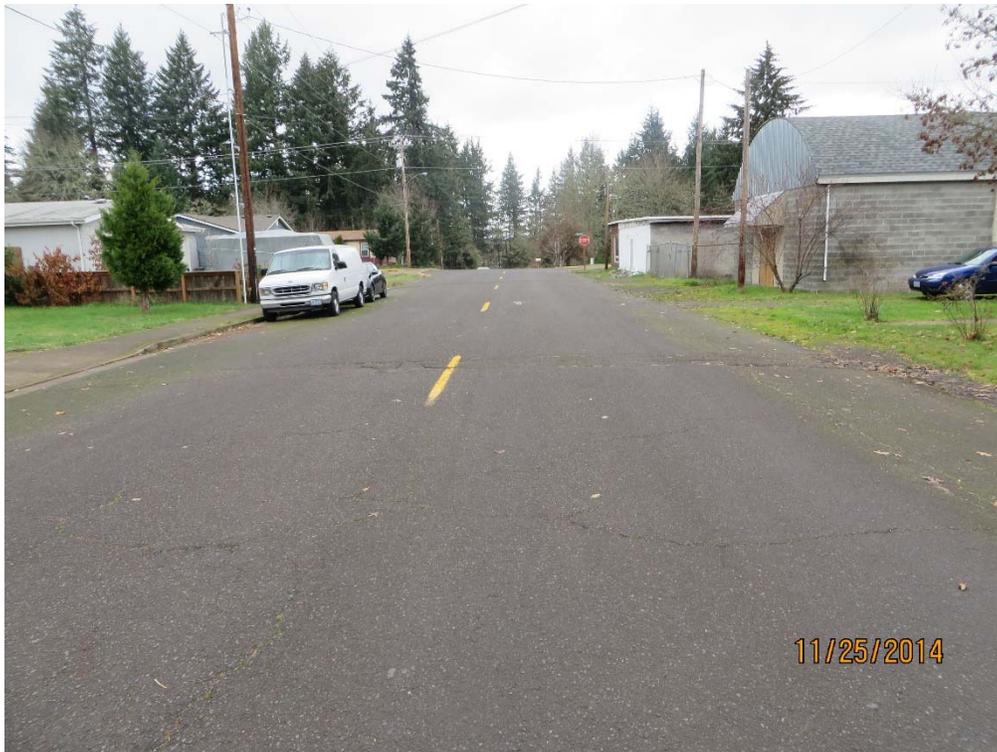
BranchID: 5TH
Name: 5th Street
SectionID: 2
From: Broadway Avenue
To: McCutcheon Avenue
PCI Before Project: 52
PCI After Project: 100
Work Type: Mill & Overlay. Full depth patching.
Approximate Cost: \$77,259
Visual Distresses: Alligator Cracking, Longitudinal/Transverse Cracking, Patching, and Weathering

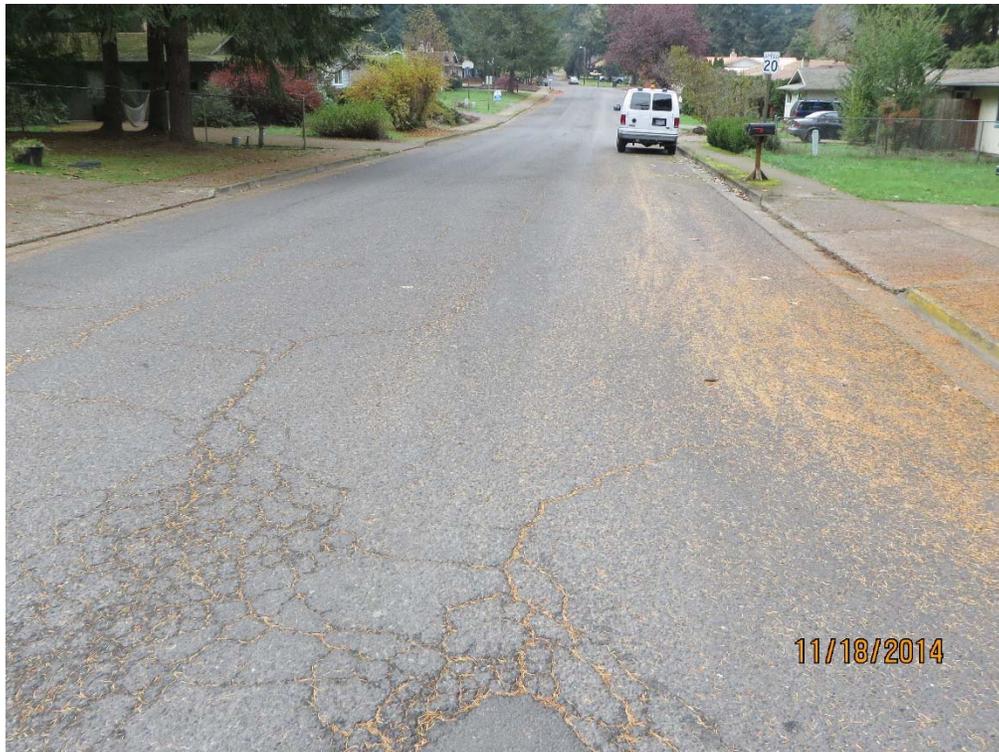
BranchID: PARKSIDE
Name: Parkside Street
SectionID: 2
From: 10th Street
To: 8th Street
PCI Before Project: 47
PCI After Project: 100
Work Type: Mill & Overlay. Full depth patching.
Approximate Cost: \$147,144
Visual Distresses: Alligator Cracking, Bleeding, Longitudinal/Transverse Cracking,
and Weathering

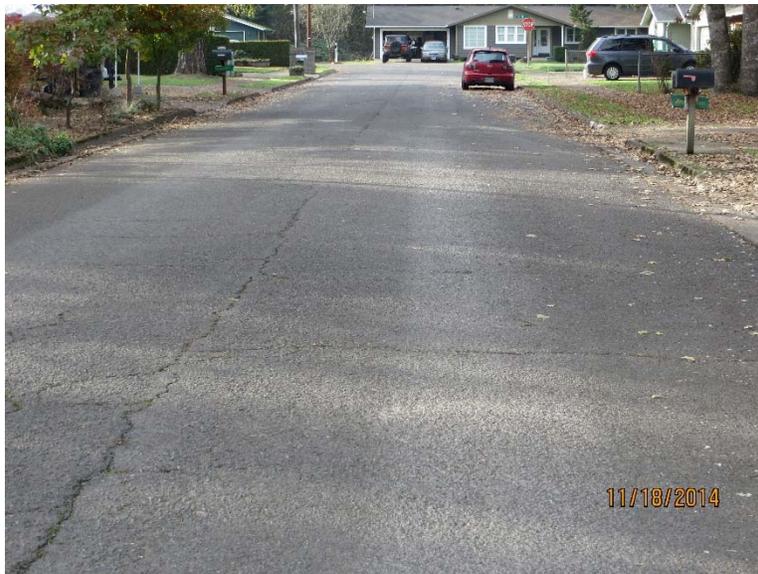
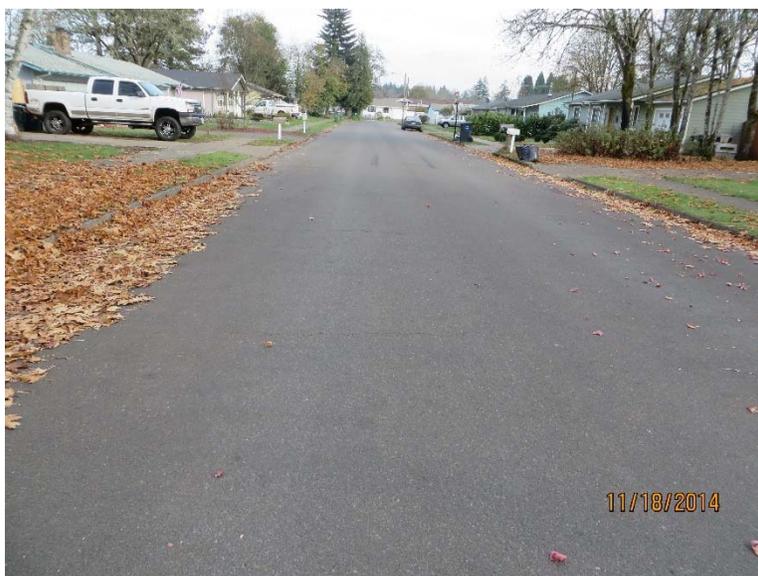
BranchID: WOODLAND
Name: Woodland Avenue
SectionID: 1 & 2
From: 6th Street
To: Meadowdale Lane
PCI Before Project: 65 & 90
PCI After Project: 74 & 95
Work Type: Slurry Seal. Crack sealing.
Approximate Cost: \$7,596
Visual Distresses: Longitudinal/Transverse Cracking and Weathering

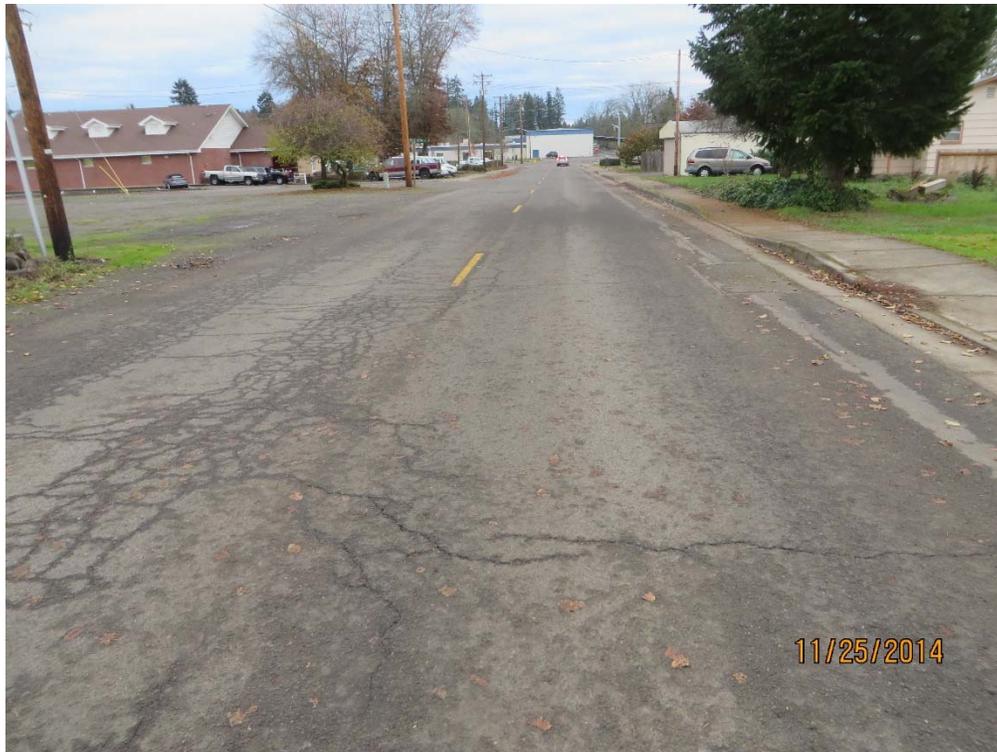
BranchID: MCCUTCHEON
Name: McCutcheon Avenue
SectionID: 1, 2 & 3
From: 8th Street
To: Territorial Road
PCI Before Project: 55, 29, 54
PCI After Project: 100
Work Type: Mill & Overlay to Reconstruction. Full depth patching.
Approximate Cost: \$278,398
Visual Distresses: Alligator Cracking, Longitudinal/Transverse Cracking, and Weathering

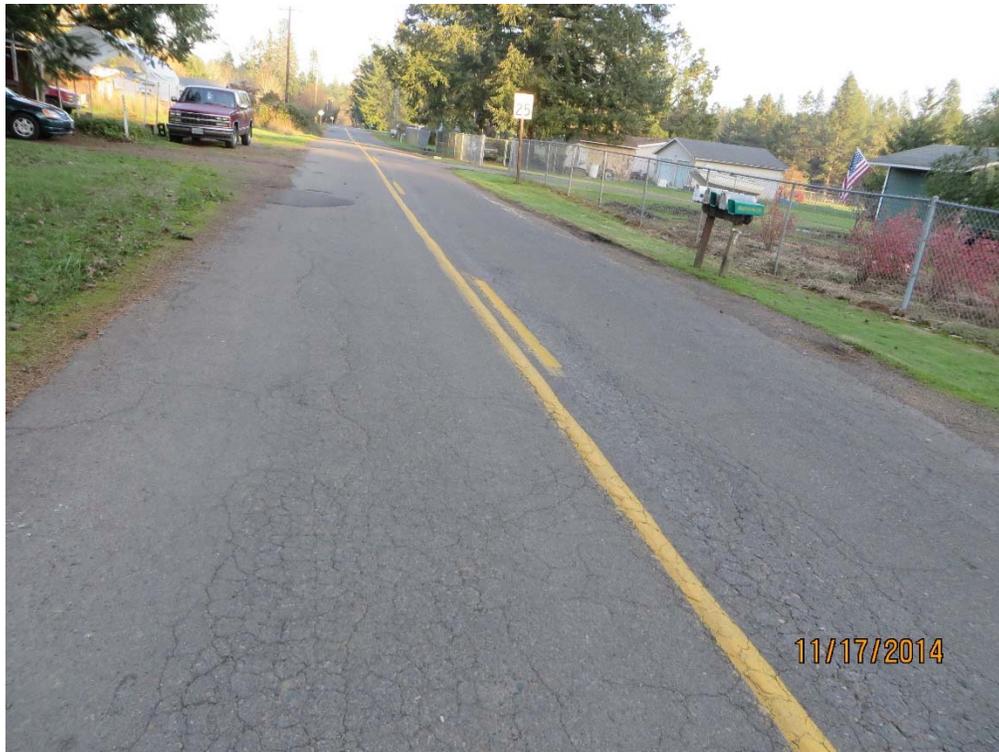
Project Year: 2017 Continued

BranchID: TIDBALL
Name: Tidball Lane
SectionID: 1
From: Huston Road
To: Eastern City Limits
PCI Before Project: 27
PCI After Project: 100
Work Type: Reconstruction.
Approximate Cost: \$57,390
Visual Distresses: Alligator Cracking, Longitudinal/Transverse Cracking, Patching, Rutting, and Weathering

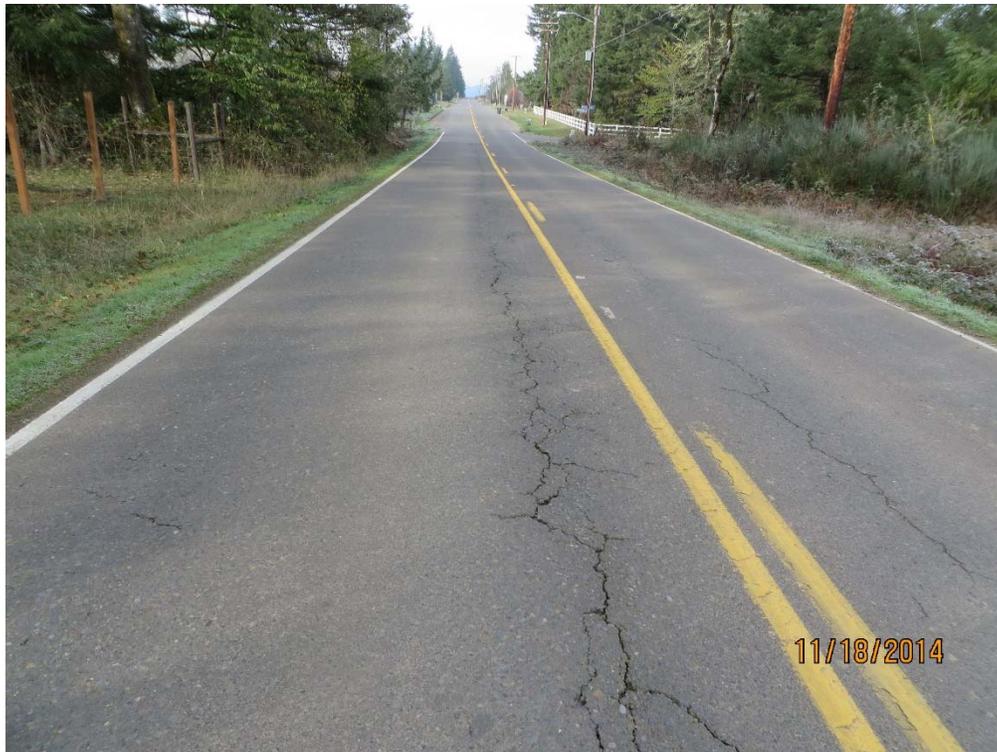
Project Year: 2018

BranchID: JEANS
Name: Jeans Road
SectionID: 2
From: Forest Meadow Lane
To: Eastern City Limits
PCI Before Project: 51
PCI After Project: 100
Work Type: Mill & Overlay. Full depth patching.
Approximate Cost: \$105,253
Visual Distresses: Alligator Cracking, Longitudinal/Transverse Cracking, and Weathering

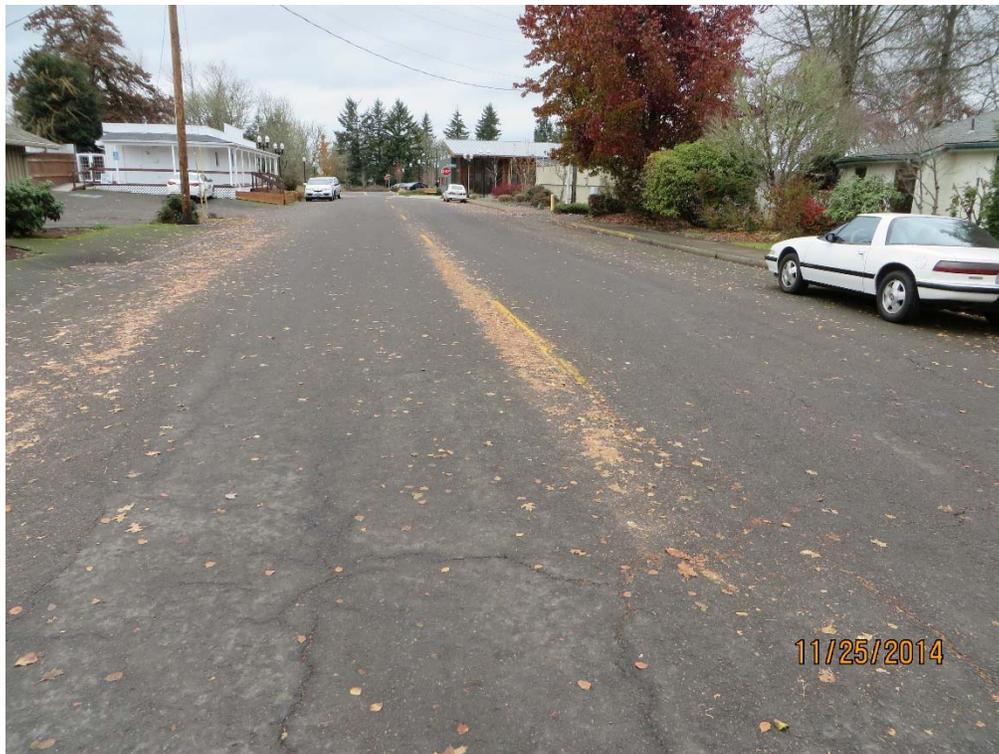
Project Year: 2018 Continued

BranchID: 2ND
Name: 2nd Street
SectionID: 2
From: Broadway Avenue
To: Dunham Avenue
PCI Before Project: 64
PCI After Project: 100
Work Type: Mill & Overlay. Full depth patching.
Approximate Cost: \$31,434
Visual Distresses: Alligator Cracking, Longitudinal/Transverse Cracking, and Weathering

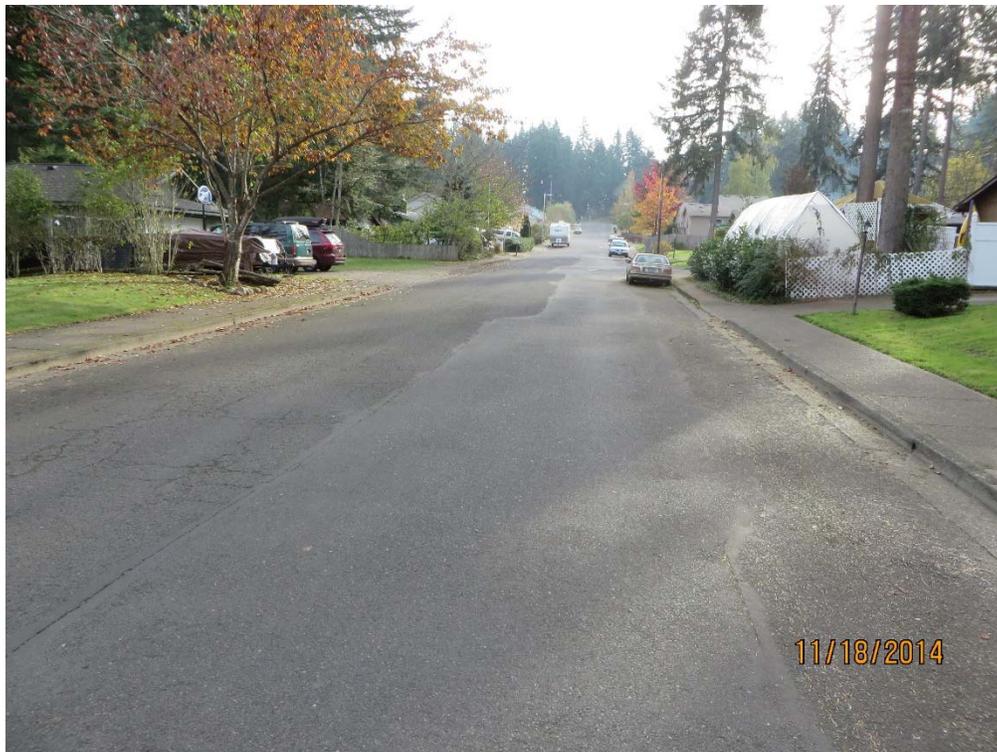
Project Year: 2018 Continued

BranchID: 9TH
Name: 9th Street
SectionID: 5
From: Parkside Drive
To: South Terminus
PCI Before Project: 54
PCI After Project: 100
Work Type: Mill & Overlay. Full depth patching.
Approximate Cost: \$126,669
Visual Distresses: Alligator Cracking, Longitudinal/Transverse Cracking, Patching and Weathering

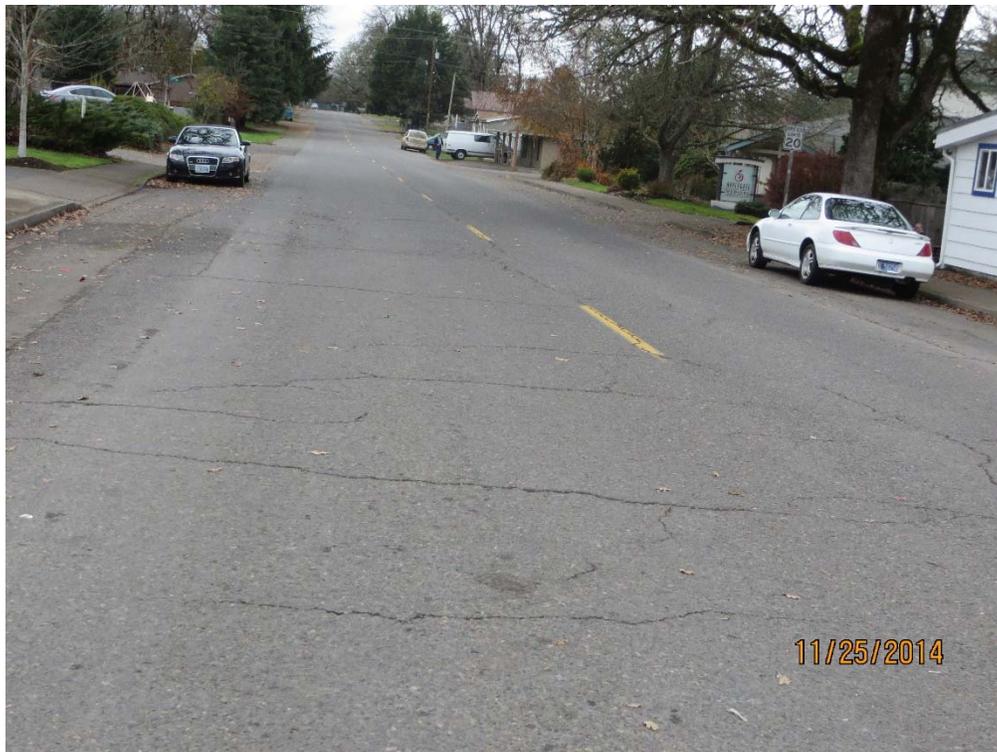
Project Year: 2018 Continued

BranchID: DUNHAM
Name: Dunham Street
SectionID: 6
From: 2nd Street
To: Territorial Road
PCI Before Project: 51
PCI After Project: 100
Work Type: Mill & Overlay. Full depth patching.
Approximate Cost: \$70,440
Visual Distresses: Alligator Cracking, Longitudinal/Transverse Cracking and Weathering

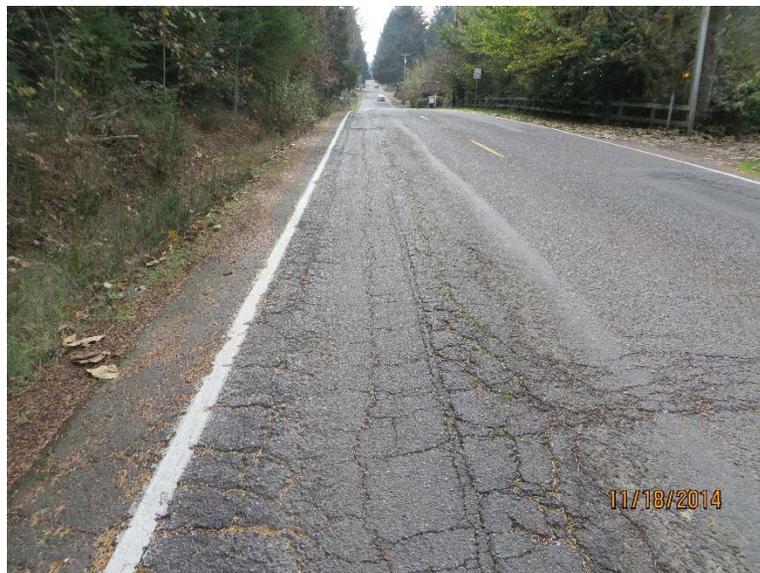
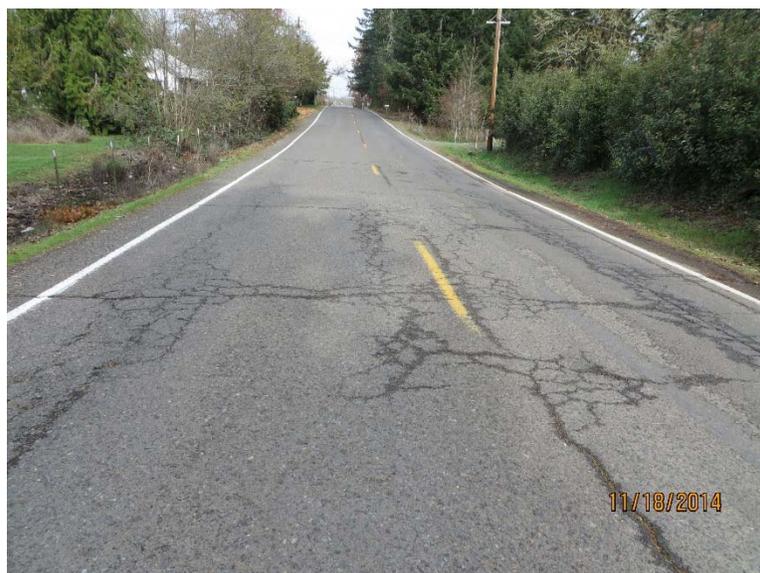
Project Year: 2019

BranchID: 8TH
Name: 8th Street
SectionID: 3
From: Dunham Avenue
To: Pavement Change north of Bolton Hill Road
PCI Before Project: 3
PCI After Project: 100
Work Type: Reconstruction
Approximate Cost: \$458,006
Visual Distresses: Alligator Cracking, Longitudinal/Transverse Cracking, Rutting, and Weathering

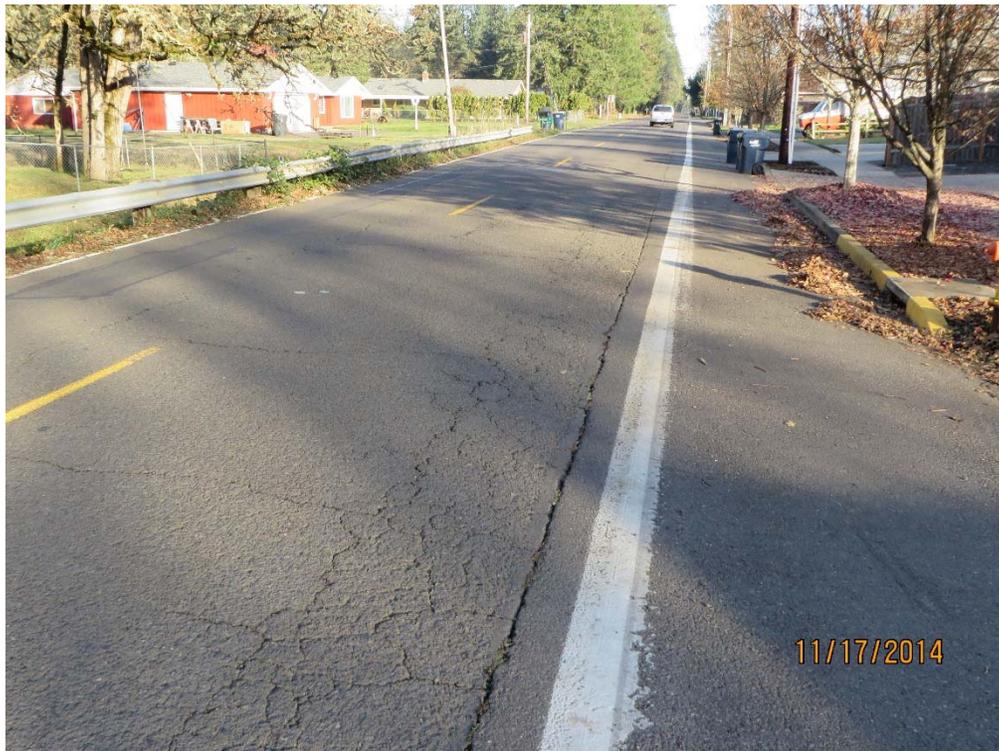
Project Year: 2020

BranchID: PERKINS
Name: Perkins Road
SectionID: 2 & 3
From: Territorial Road
To: Pavement Change east of Oak Island Road
PCI Before Project: 27 & 23
PCI After Project: 100
Work Type: Reconstruction.
Approximate Cost: \$247,706
Visual Distresses: Alligator Cracking, Bleeding, Longitudinal/Transverse Cracking, Patching, Pothole, and Weathering
Comments: If funding is available, we recommended that PERKINS_4 is also reconstruct, which extends to the eastern City Limits.
